Town of Williamson

Route 21 & 104 Gateway Study

Final Report

July 2008

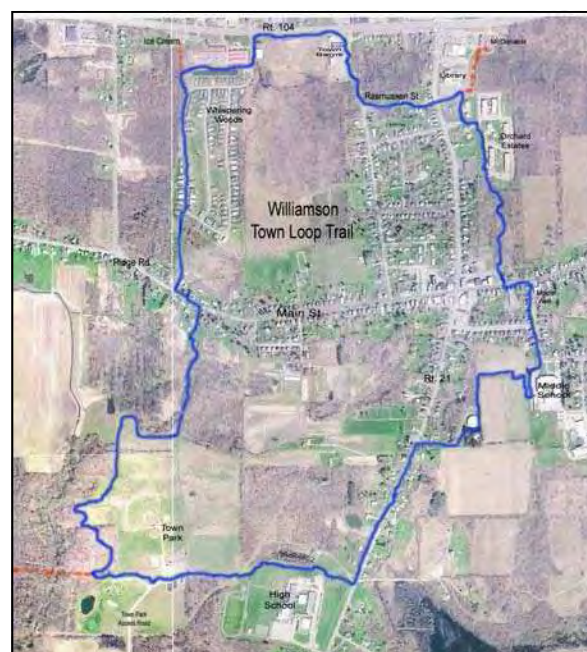
The Williamson Town Loop Trail. This is a trail system made up of various sidewalks and other trails located throughout the Town. (Image courtesy of Town of Williamson)

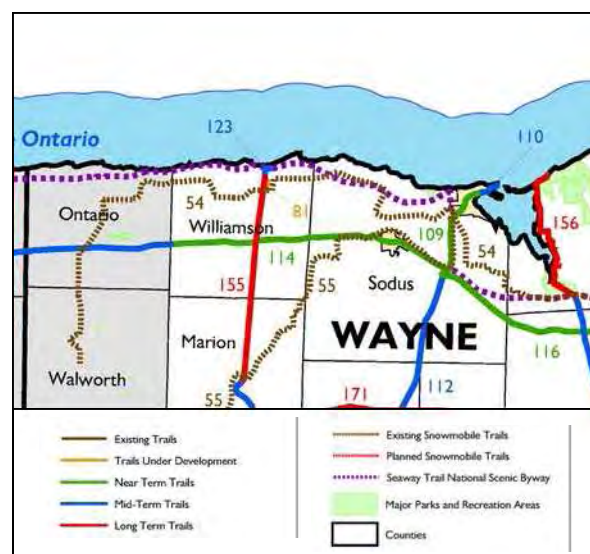
Excerpt from GTC Regional Trails Initiative - Phase II map. (Image courtesy of GTC)

There are currently two proposed/suggested trails identified by the GTC report for Williamson: Trail #114 (Route 104 Corridor Trail) and Trail #155 (Pultneyville to Marion Trail). Trail #114 was classified as “planned near-term” which indicates the proposal has been identified in other local planning documents and is recommended for near-term implementation, while Trail #155 was suggested as a long-term project and has not been identified in any other plans or documents. The Route 104 Corridor Trail would be a multi-use trail parallel to the existing snowmobile trail (SS Trail #4 described above) and the Pultneyville to Marion trail would run from the hamlet to the northern terminus of the planned Newark to Marion trail. At the time of this report, the status of these trails remains as they were when the report was published in 2004 until an organization or municipality requests funding through the Priority Trails Advancement Program.

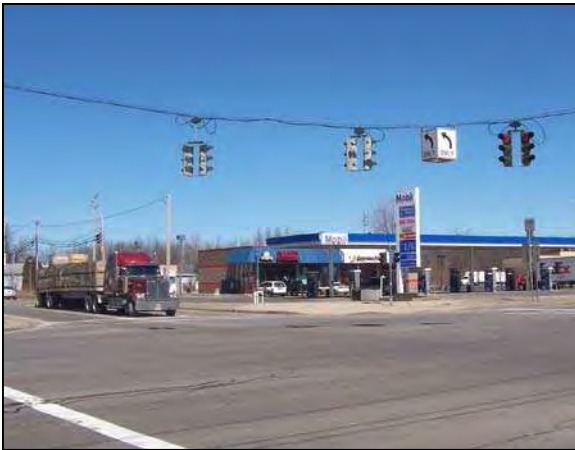
Northeastern corner of Route 21 and 104 - trucks in this corridor typically haul farm goods, such as this truck carrying full apple crates.

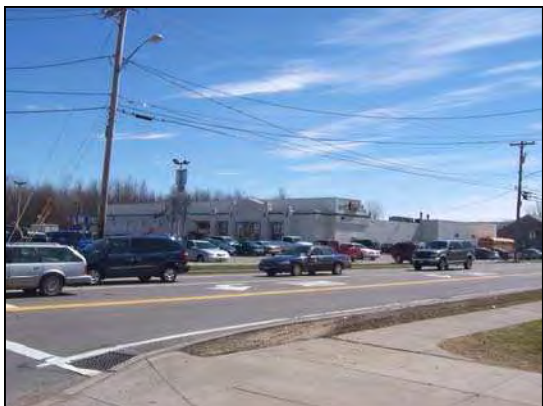
According to observations, southbound traffic on Route 21 near Breen's IGA occasionally backs up, increasing the potential for accidents.

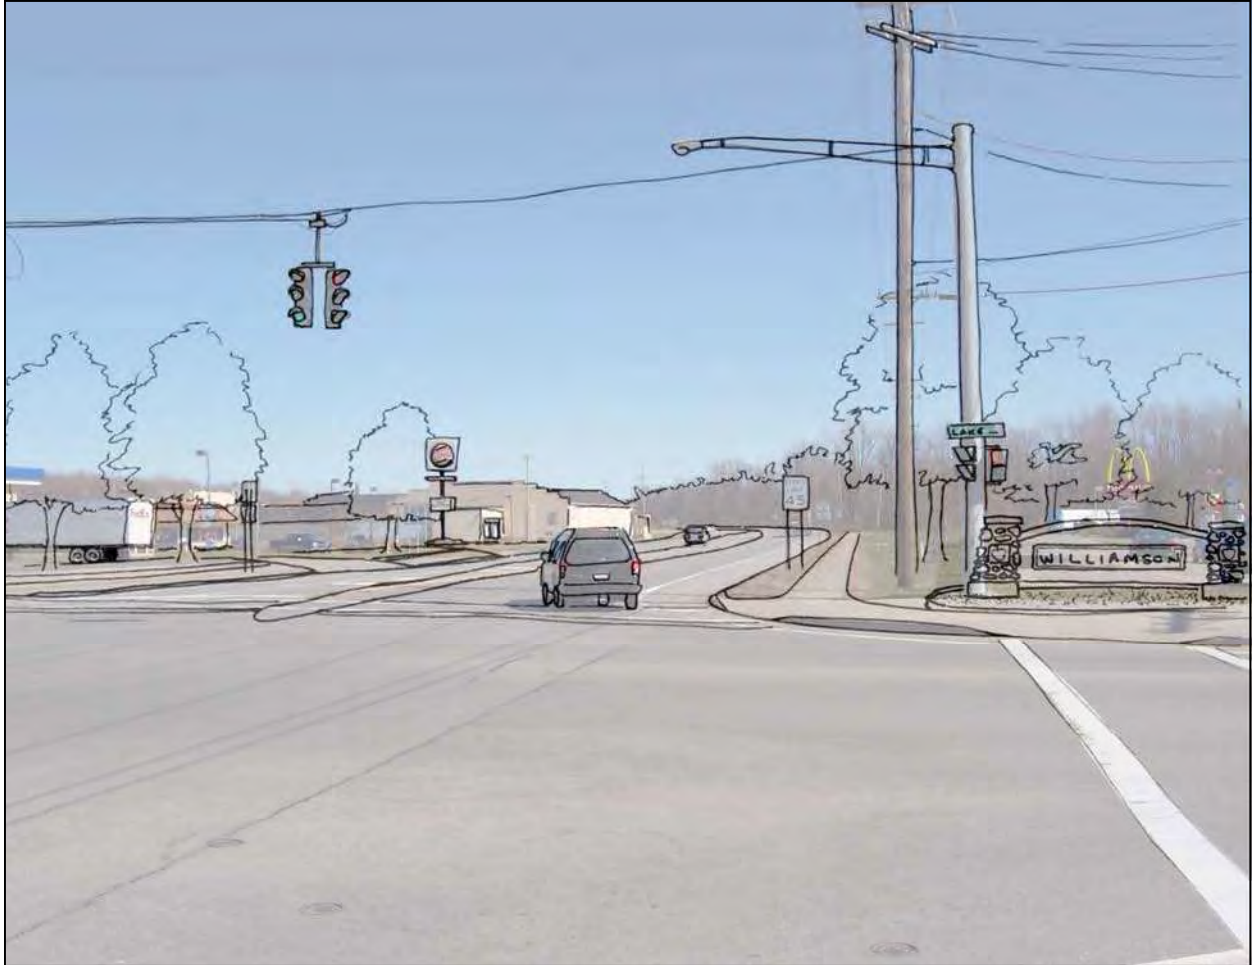
(Top) A sketch simulation of Route 104 looking westbound from the Route 21 intersection superimposed over an existing photograph.

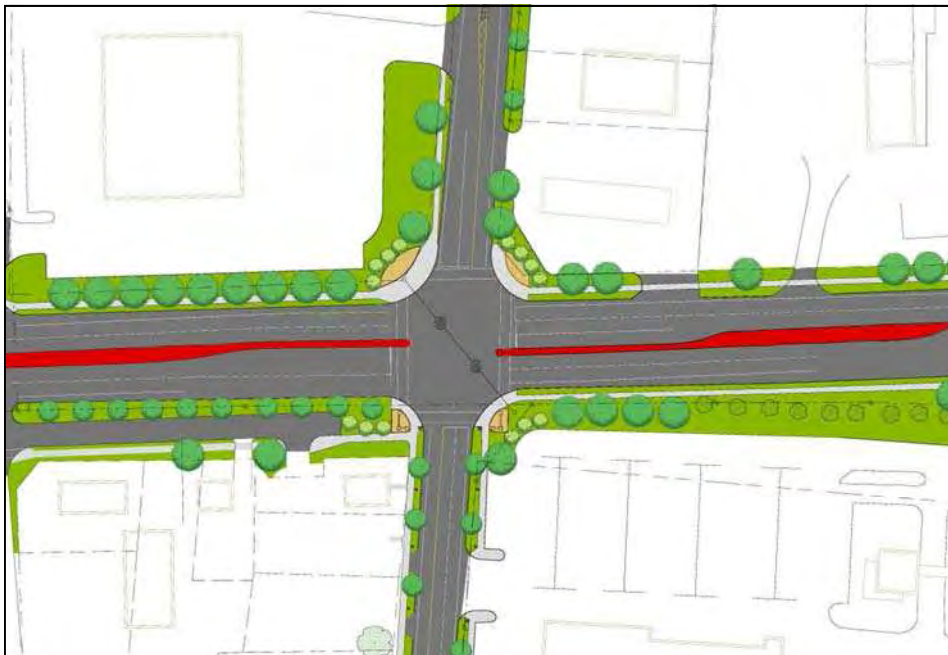
(Left) Plan view of the proposed roadway design and streetscape improvements at the Route 21 & 104 intersection shown above. Some of the features indicated in the 2005 Vision Plan were incorporated into this final conceptual design.

The final concept plan for the corridor retains a majority of the design features with some changes to the quantity and location of trees and the extent and design of the center median. NYS DOT's Highway Design Manual was utilized to determine the proper location for trees in relation to turning maneuver sight distances and edge of road offset distances. Although a raised center median is functionally and physically feasible, a flush, colored median is recommended for Route 104 at this time. Trees along the corridor were strategically placed based on the required clear zones that are specified within the Design Manual.

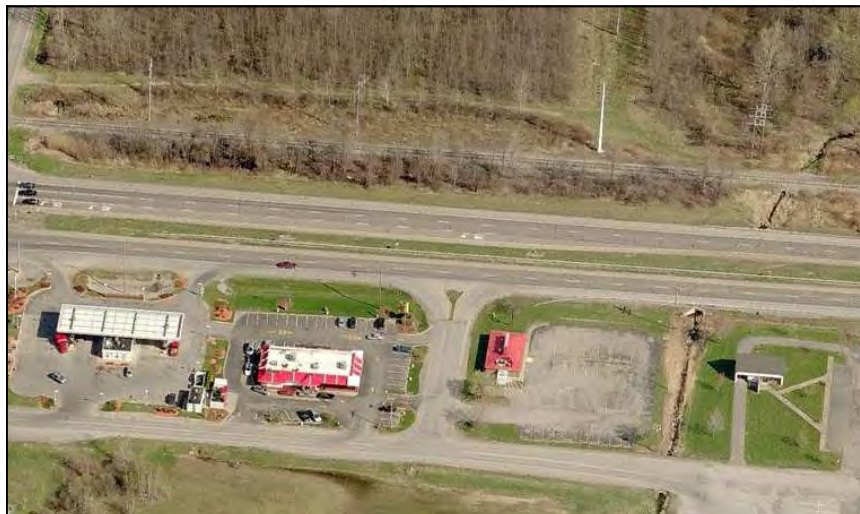
*The median in Ontario, NY - a guardrail and a wide, grassy area.
(Image courtesy of Microsoft Live Local)*

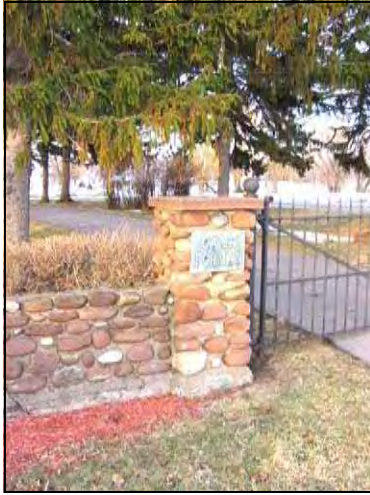
The gateway sign should utilize native materials, such as "lake stone."

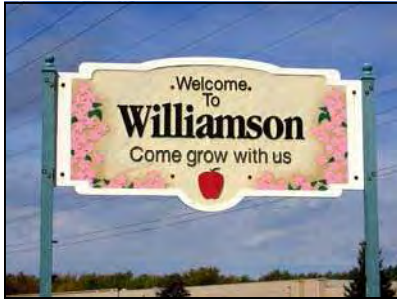
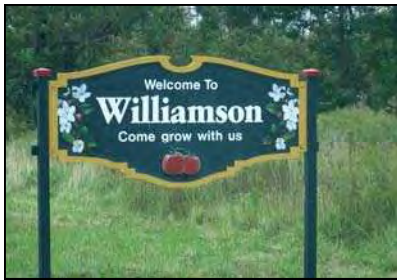
Welcome signs currently found within the Town. A single style and scheme should be followed.

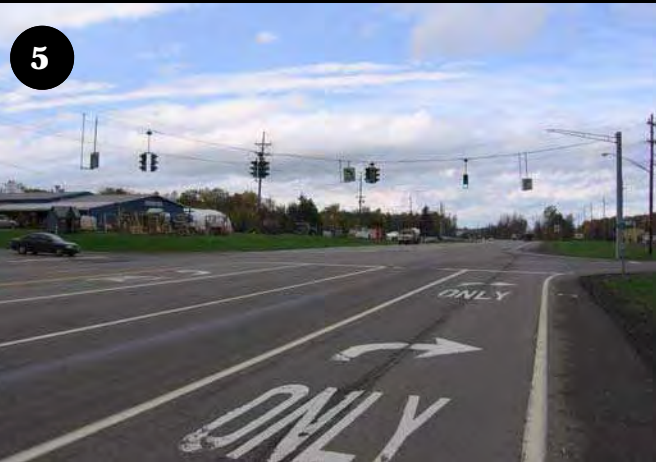
- 1. "Welcome To Williamson" sign
- 2. Small grove of flowering trees to resemble an apple orchard
- 3. Flush median with colored and textured surface
- 4. Street trees
- 5. The existing cross section of NYS Route 104 west of Pound Road is shown below.

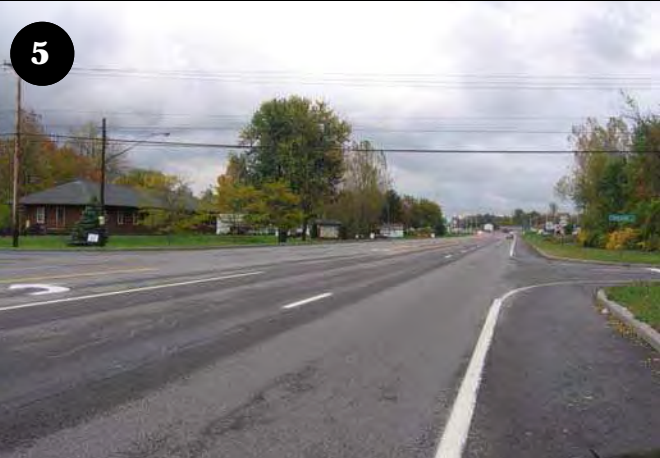
- 1. "Welcome To Williamson" sign
- 2. Small grove of flowering trees to resemble an apple orchard
- 3. Flush median with colored and textured surface
- 4. Street trees
- 5. The existing cross section of NYS Route 104 east of Tuckahoe Road is shown below.

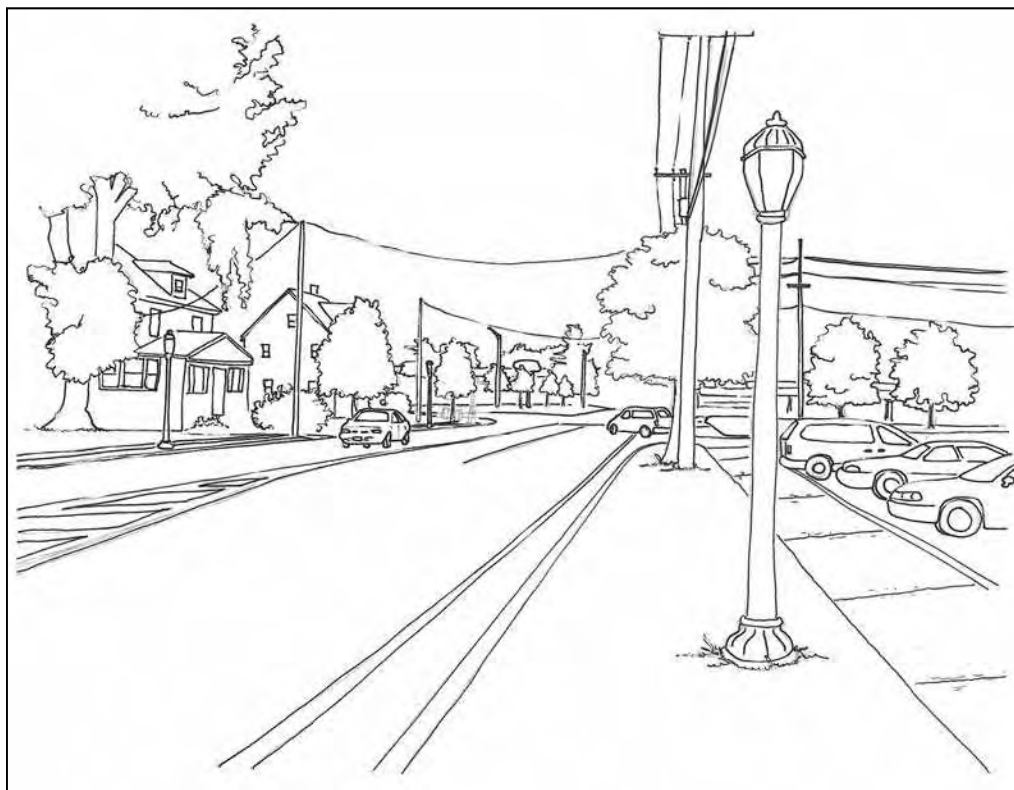
Simulation of State Route 21 looking northbound to Route 104 with an expanded tree lawn, lighting, and additional plantings.

The existing tree lawn along the east side of Route 21 is minimal and the amount of space available for landscaping is inadequate. The reconstruction along the east side of Route 21 would allow smaller trees and pedestrian lighting to be installed with equal lawn on each side of the street. The pedestrian lighting would be a design chosen by the

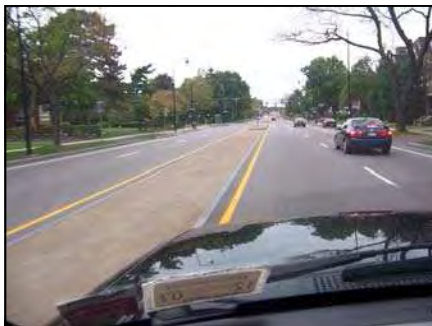
Flush median with stamped concrete and flush granite curbing on Lake Avenue in the City of Rochester.

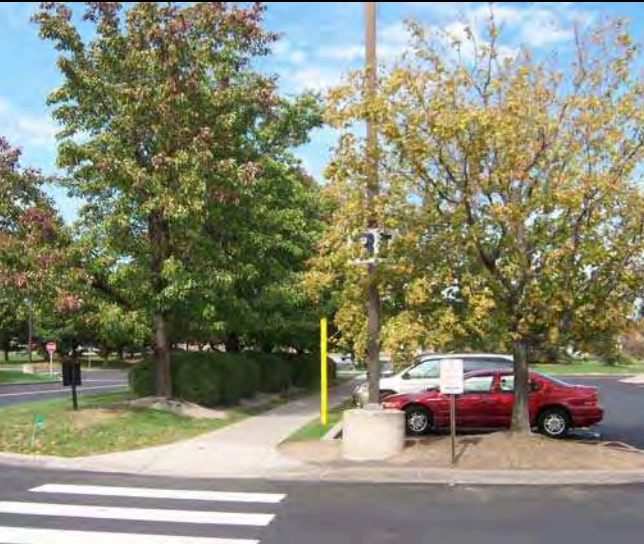
1. Flush medians with colored & textured surfaces
2. Vegetation with year round interest (shrubs, grasses, etc)
3. Street trees
4. Monument signs

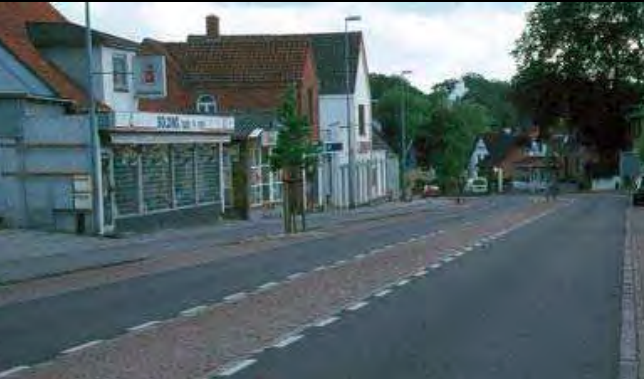
Example of flush median using colored pavers

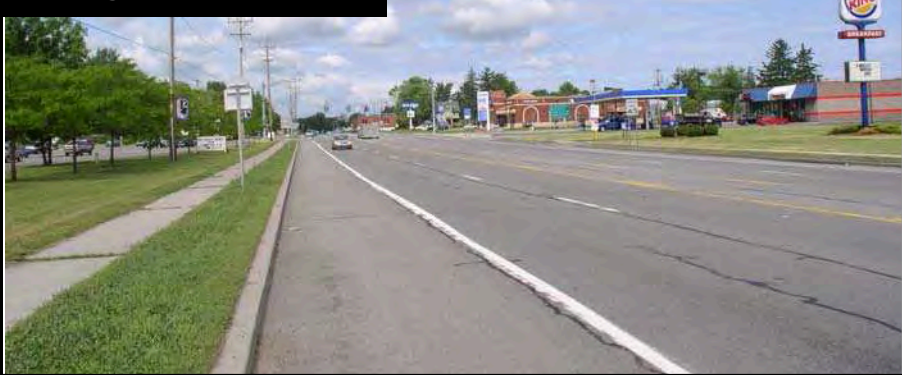
Proposed Cross Section

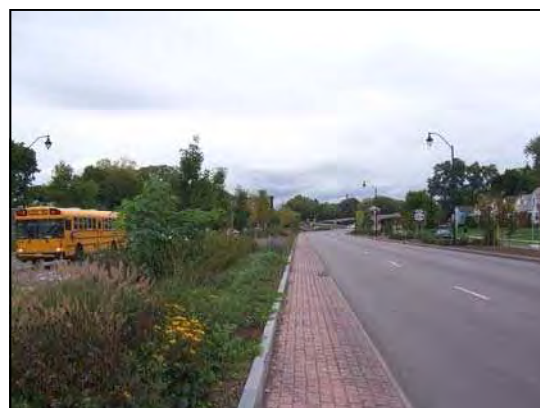
Similar raised median designs on Route 441 in Penfield (top) and on Route 104 in the City of Rochester (bottom); these could be utilized in Williamson at the appropriate time.

the right-of-way, vehicular traffic flow, and the proximity of businesses along the roadway, a raised median would be functionally and physically feasible along Route 104 with median breaks at key intersections. However, a raised median is not recommended at this time.

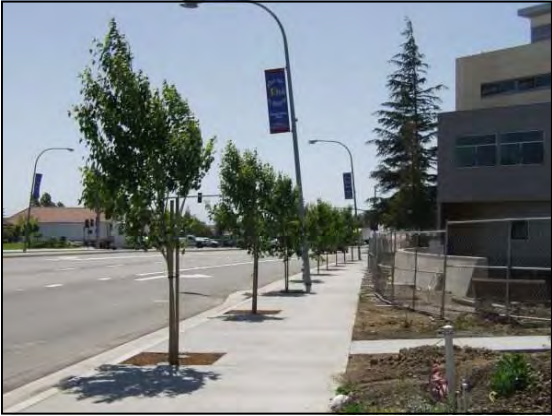
*Roadside trees improve aesthetics and slow traffic by making the street appear narrower.
(Image courtesy of Overland Park, KS)*

3. *Unify the corridor with roadside trees* - Suburban commercial development is usually discontinuous and visually fragmented. Regularly spaced deciduous trees along the road frontage provide visual unity; improve aesthetics; and slow traffic by making the street appear narrower. Consistent tree plantings should be required with every proposed project in the corridor.

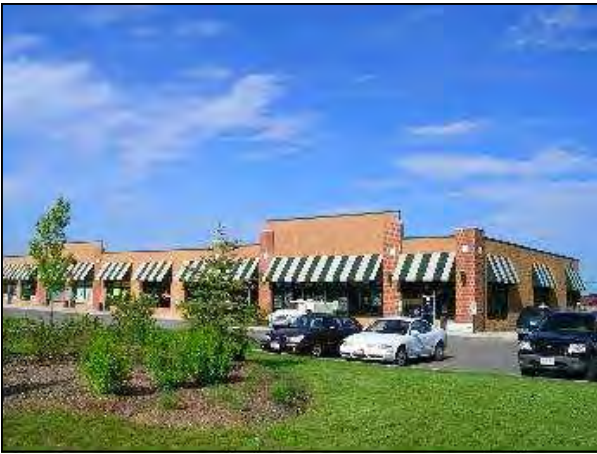
Retail store utilizing awnings over sidewalk windows.

- f. Awnings should be no longer than a single storefront and fit the opening behind it.
 - g. On both fully extended roll-up awnings

and fixed awnings, the lower flap of the awning should be at least 8' above the sidewalk.

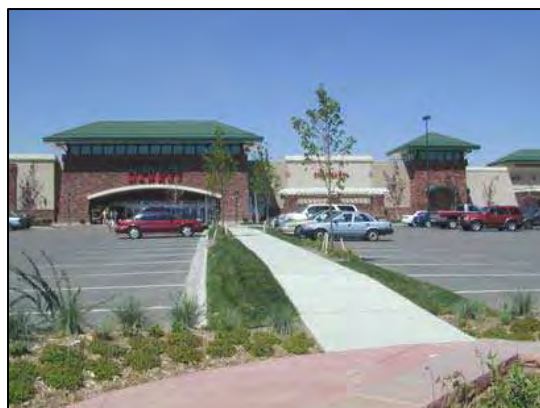
Sidewalks can be designed into parking lots for pedestrian safety and to break up large expanses of asphalt. (Image courtesy of Overland Park, KS)

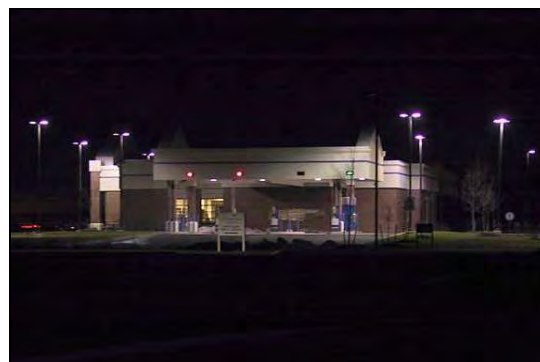
Good example of cutoff lighting of a business.

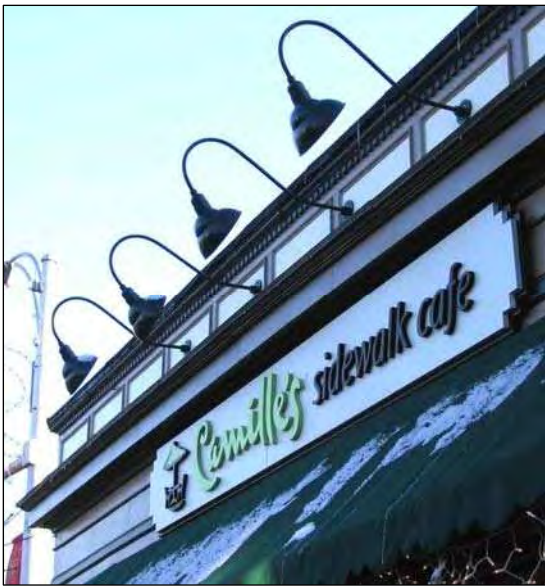
A good example of shielded lighting on a sign that is well designed for the business.

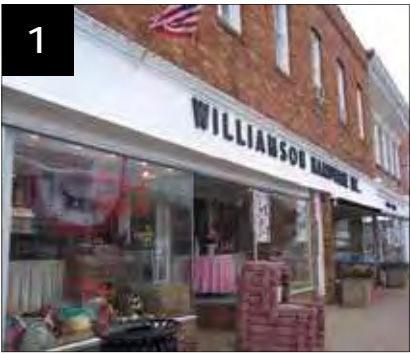
Williamson Hardware
Landscaping: Fair
Façade/Structure: Good, Brick
Signage: Good, 1 wall sign
Sidewalk: Good, 8’ concrete
Notes: Late 19th century 2-sty brick commercial block with mid-20th century plate glass storefront. Pedestrian friendly.

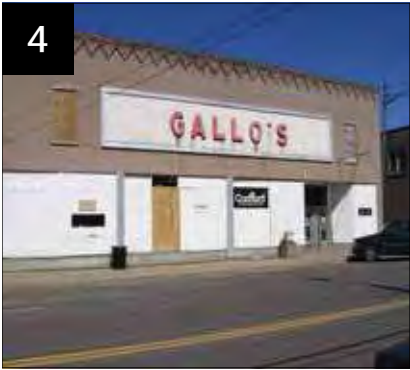
Gallo's, 4119 Ridge Rd
Landscaping: Fair
Façade/Structure: Poor, Brick
Signage: Poor, 1 wall sign
Sidewalk: Good, 8’ concrete
Notes: Circa 1900 2-sty brick commercial block, oversized sign 2nd floor, windows & storefront boarded up, small entrance.

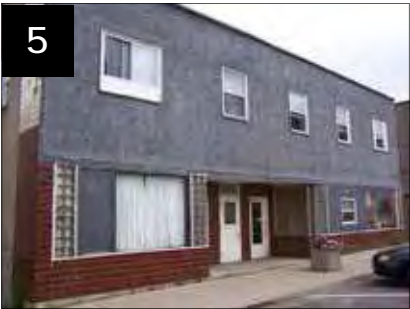
Vacant, 4121-4125 Ridge Rd
Landscaping: Fair
Façade/Structure: Poor, some brick
Signage: Poor, 2 window signs
Sidewalk: Good, 8’ concrete
Notes: Mid 20th century 2-sty commercial building altered by replacement windows & removal of brick veneer (hangers exposed).

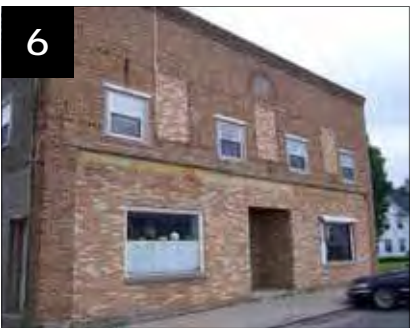
Barber Shop/ other tenants
Landscaping: Fair
Façade/Structure: Fair
Signage: None
Sidewalk: Good, 8’ concrete
Notes: Early 20th century 2-sty commercial brick building with façade altered by replacement windows and brick infill at storefront.

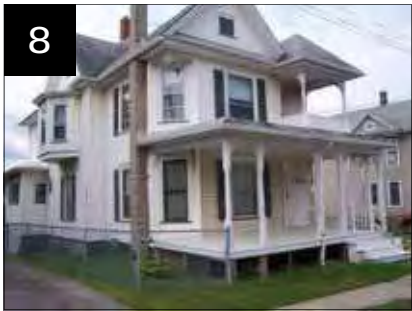
Residence, 4132 Ridge Rd
Landscaping: Fair
Façade/Structure: Fair, Vinyl
Signage: None
Sidewalk: Good, 4' concrete
Notes: Roof maintenance. Circa 1895 Queen Anne house.

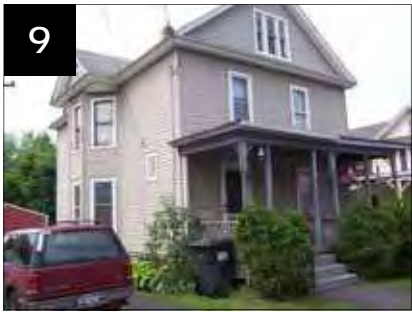
Residence, 4126 Ridge Rd
Landscaping: Good
Façade/Structure: Good, Wood
Signage: None
Sidewalk: Good, 4' concrete
Notes: Porch maintenance. Circa 1900 Queen Anne house.

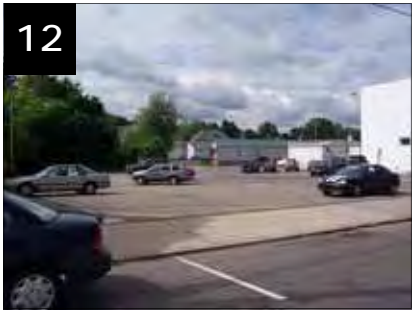
Parking Lot
Landscaping: None
Façade/Structure: None
Signage: None
Sidewalk: Good, 8' concrete
Notes: Unknown if public or private lot, no signage, road markings very faded.

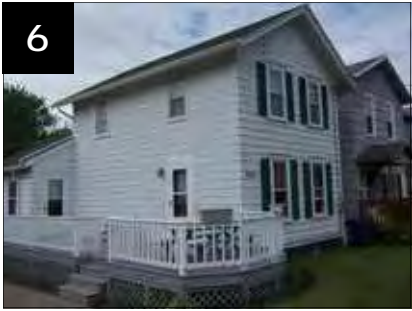
Residence, 4139 Ridge Rd
Landscaping: Fair
Façade/Structure: Good, Wood shakes
Signage: None
Sidewalk: Good, 4' concrete
Notes: Connected to the structure to the west. Mid 19th century Vernacular house.

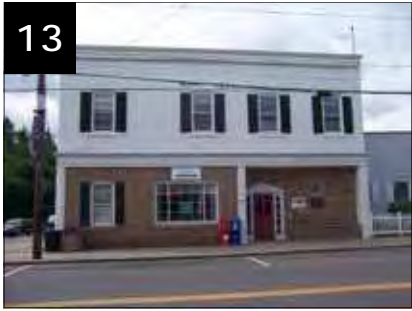
Ontario Physical Therapy; Cornerstone Assoc. Realty, 4100 Ridge Rd
Landscaping: Fair
Façade/Structure: Good, Brick/Vinyl
Signage: Good, 2 wall signs
Sidewalk: Good, 8' concrete
Notes: Former location of Town Hall, late 19th century commercial building with bricked-in storefront.

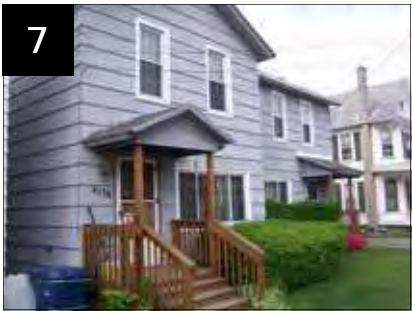
Residence, 4136-4134 Ridge Rd
Landscaping: Fair
Façade/Structure: Good, Wood shakes
Signage: None
Sidewalk: Good, 4' concrete
Notes: Same as note above.

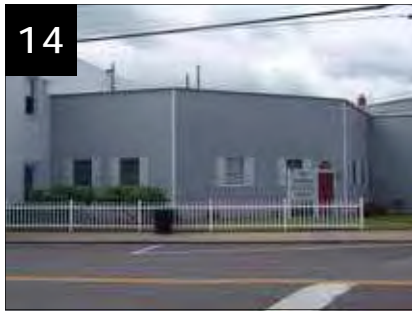
Business Mgmt. Services; Cole Income Tax Services; Robert E. Bryan CFP, 4098 Ridge Rd
Landscaping: Fair
Façade/Structure: Fair, Vinyl
Signage: Good, 1 freestanding sign
Sidewalk: Good, 8' concrete
Notes: Large corner lot with no arch. Details, smaller windows, inconsistent with other corners.

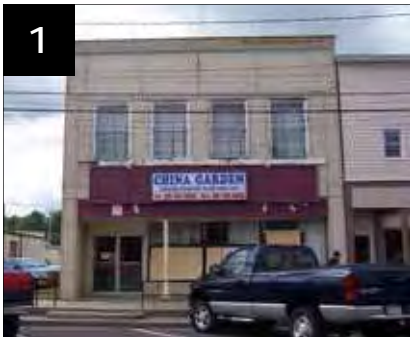
China Garden (vacant)
Landscaping: None
Façade/Structure: Fair, Brick
Signage: Fair, 1 lighted wall sign
Sidewalk: Good, 8' concrete
Notes: Early 20th century brick commercial building with ADA ramp.

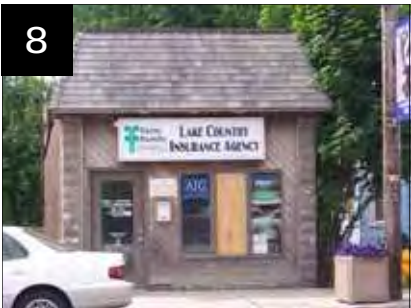
Lake Country Insurance Agency
Landscaping: Fair
Façade/Structure: Fair, Wood shakes
Signage: Fair, 3 signs
Sidewalk: Good, 8' concrete
Notes: Early 20th century single-story commercial building with circa 1980 façade, multiple signs of various sizes/types, boarded windows.

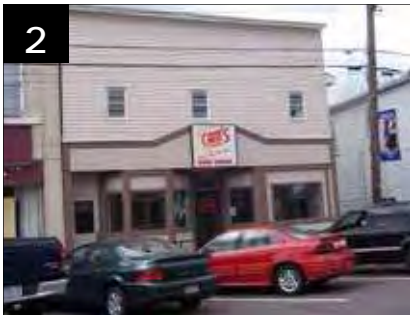
Cam's Pizzeria
Landscaping: None
Façade/Structure: Good, Wood
Signage: Good, 1 lighted wall sign
Sidewalk: Good, 8' concrete
Notes: Circa 1900 commercial building with altered storefront & small 2nd floor replacement windows and ADA ramp.

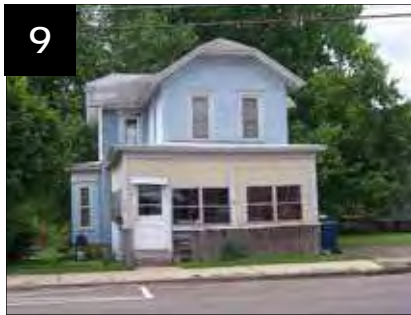
Residence, 4060 Ridge Rd
Landscaping: Fair
Façade/Structure: Fair, Wood/Vinyl
Signage: None
Sidewalk: Good, 4' concrete
Notes: Circa 1890 Vernacular house with enclosed porch, porch windows appear to have been larger.

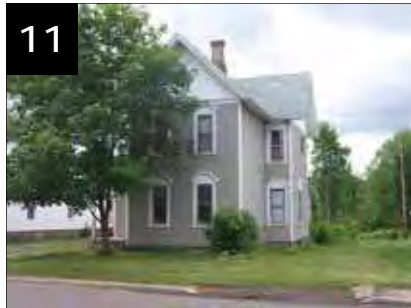
Residence, 4122 Ridge Rd
Landscaping: Fair
Façade/Structure: Good, Vinyl
Signage: None
Sidewalk: None
Notes: Large tree blocking façade, 2nd curb cut on west side, circa 1880 Queen Anne house.

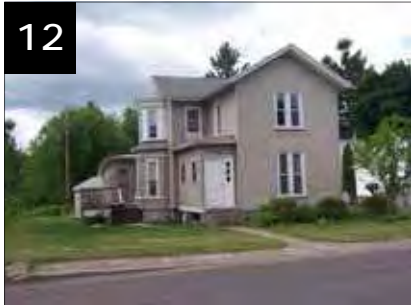
Residence, 4046 Ridge Rd
Landscaping: Good
Façade/Structure: Good, Vinyl
Signage: None
Sidewalk: Fair, 4' concrete
Notes: Sidewalk resumes here, circa 1880 Italianate with enclosed porch.

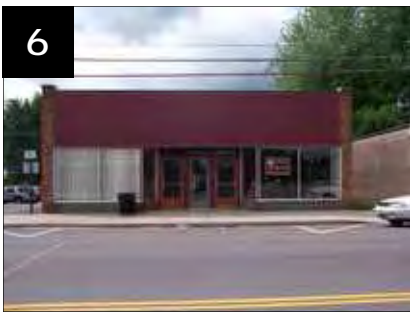
Community of Faith Church, 4064-4066 Ridge Rd
Landscaping: None
Façade/Structure: Good, Brick
Signage: Fair, 1 window sign
Sidewalk: Good, 8' concrete
Notes: Blank upper façade, sign not legible to auto traffic, mid 20th century single-story.

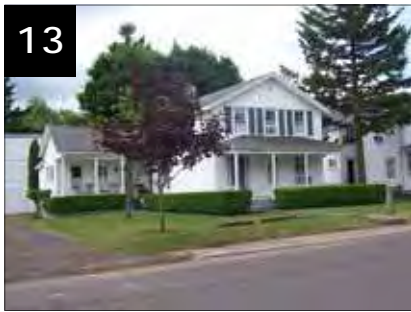
Residence, 4042 Ridge Rd
Landscaping: Good
Façade/Structure: Good, Vinyl
Signage: None
Sidewalk: Fair, 4' concrete
Notes: Aged sidewalk, early 19th century house.

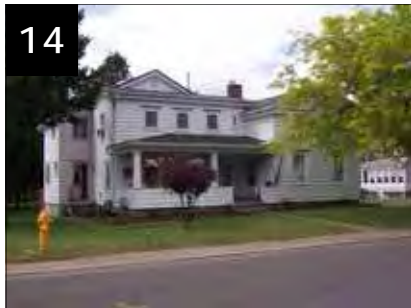
Residence, 4038 Ridge Rd
Landscaping: Good
Façade/Structure: Good, Vinyl
Signage: None
Sidewalk: Fair, 4' concrete
Notes: Aged sidewalk with uneven surface, circa 1840 Greek revival house with later additions.

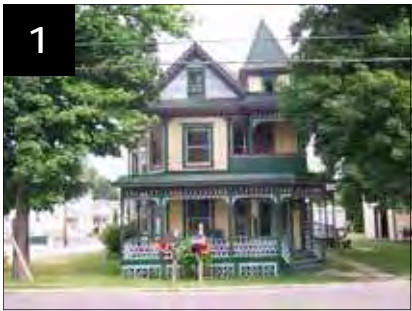
1
Residence, 4035 Ridge Rd
Landscaping: Good
Façade/Structure: Good, Brick
Signage: None
Sidewalk: None
Notes: Many façade details, circa 1890 Queen Anne house.

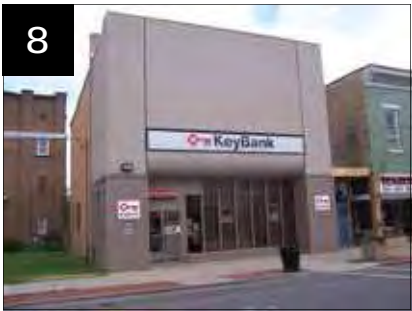
8
Key Bank
Landscaping: Fair
Façade/Structure: Fair, Stucco/Metal
Signage: Fair, lighted wall & wall signs
Sidewalk: Good, 6' concrete/brick
Notes: 1960's façade applied over older building, blank façade, tinted windows, standard corporate signage.

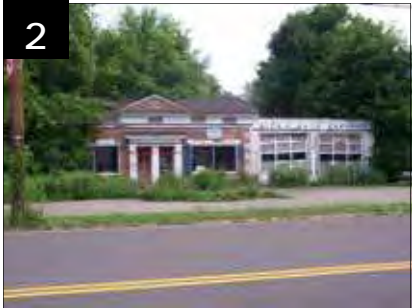
2
Rick's Auto Service (vacant)
Landscaping: Poor
Façade/Structure: Poor, Brick
Signage: Fair, 1 wall sign
Sidewalk: None
Notes: Dilapidated building, faded paint, overgrown vegetation, Greek revival with 20th century garage addition.

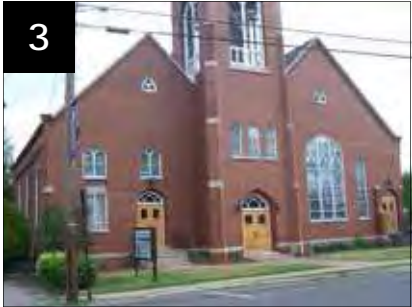
3
First Presbyterian Church
Landscaping: Good
Façade/Structure: Good, Brick & Stained Glass
Signage: Good, changeable type sign
Sidewalk: Good, 4' concrete
Notes: Circa 1900 Gothic revival church.

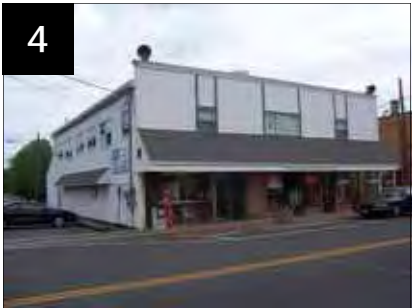
4
Wash House Laundromat, 4067 Ridge Rd (left end)
Landscaping: Fair
Façade/Structure: Good, Vinyl/Wood
Signage: Poor, wall sign
Sidewalk: Good, 6' concrete/brick
Notes: Sign located on side of building, mid 20th century building with late 20th century faced treatment.

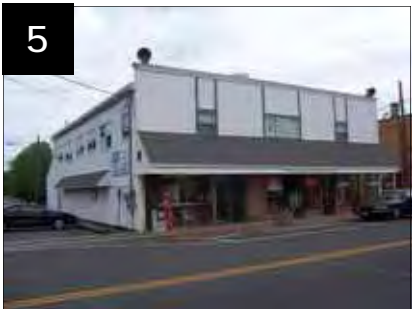
5
Original Candy Kitchen (middle)
Landscaping: Fair
Façade/Structure: Good, Vinyl/Wood
Signage: Good, 3 neon signs
Sidewalk: Good, 6' concrete/brick
Notes: Same building as #4, sign for tenant may be difficult to see for auto traffic.

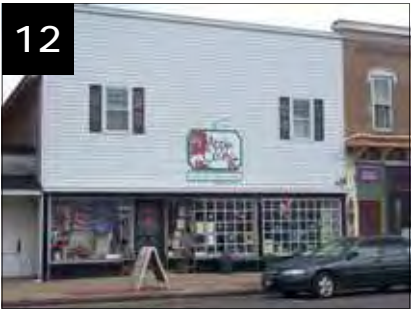
12
Apple Crate
Landscaping: Good
Façade/Structure: Good, Wood
Signage: Good, wall sign
Sidewalk: Good, 6' concrete/brick
Notes: "Busy" window display, but well kept. Late 20th century façade on 19th century commercial building.

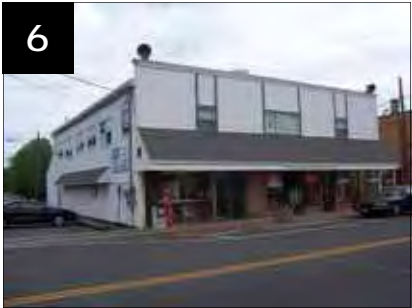
6
Little Bit Country-Little Bit Rock N' Roll & Original Candy Kitchen (right side)
Landscaping: Fair
Façade/Structure: Good, Vinyl/Wood
Signage: Fair, window sign
Sidewalk: Good, 6' concrete/brick
Notes: Same building as #4, sign not professional (paper sign) and small.

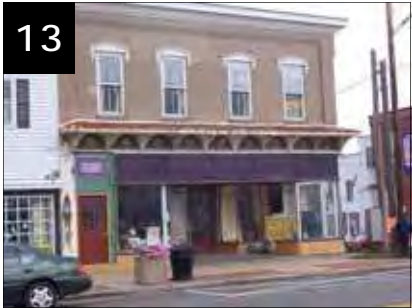
13
Art & Soul by MJ Design
Landscaping: Good
Façade/Structure: Fair, Brick
Signage: Fair, window painted
Sidewalk: Good, 6' concrete/brick
Notes: Window sign difficult to read, large pedestrian windows, rust stains on overhang, circa 1870 Italianate. Appears partially vacant.

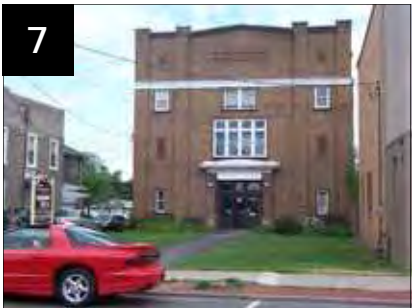
7
Shear Dimensions Salon; Reformed Fellowship Church, 4075 Ridge Rd
Landscaping: Good
Façade/Structure: Good, Brick
Signage: Good, window & freestanding
Sidewalk: Good, 6' concrete /brick
Notes: Façade details, some windows bricked up, early 20th century brick religious bldg.

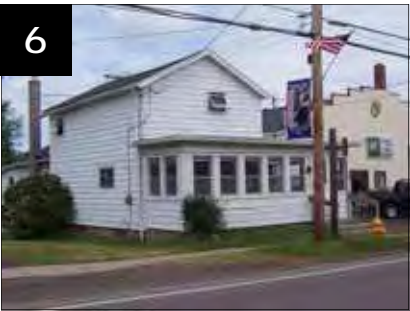
Residence, 6149 SR 21
Landscaping: Poor
Façade/Structure: Fair, Aluminum
Signage: None
Sidewalk: Good, 4’ concrete
Notes: Lawn is overgrown, few upper story windows, 19th century house.

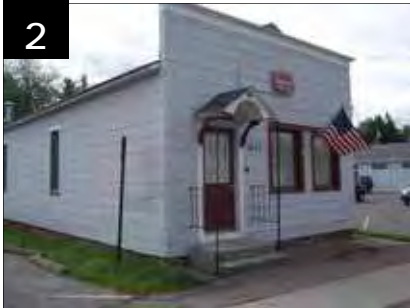
Orphix Fraternity, 6152 SR 21
Landscaping: Poor
Façade/Structure: Fair, Wood shake
Signage: Fair, 1 lighted wall sign
Sidewalk: Good, 8’ concrete/asphalt
Notes: Small sign, barely legible. Circa 1920 single-story commercial building.

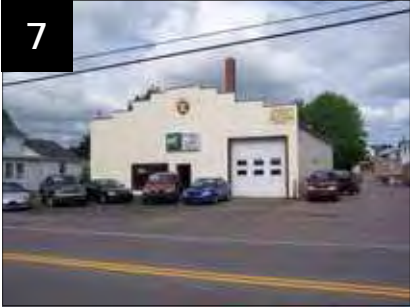
Kings Auto Sales and Accessories
Landscaping: None
Façade/Structure: Good, Concrete block
Signage: Good, 1 wall & 1 lighted sign
Sidewalk: Good, 6’ concrete /brick
Notes: Signs are legible and well-kept. The building is on the same parcel as Kings Auto Sales, although the building is not connected. Circa 1940 garage.

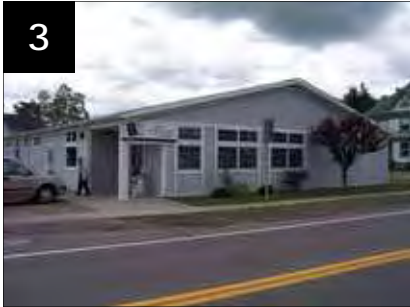
United States Postal Service
Landscaping: Good
Façade/Structure: Good, Vinyl
Signage: Good, 1 freestanding sign
Sidewalk: Good, 4’ concrete
Notes: Signage set in parking lot, not in front of the building. Many windows. Circa 1995.

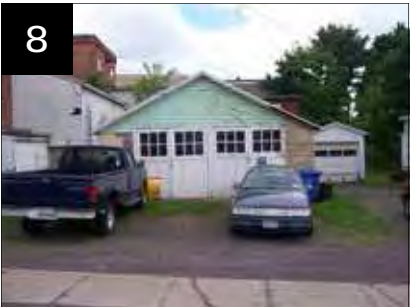
Private garage
Landscaping: Poor
Façade/Structure: Fair, Block/Wood
Signage: None
Sidewalk: Fair, 4’ concrete
Notes: Unknown property owner of structure. Façade needs maintenance. Circa 1910 garage.

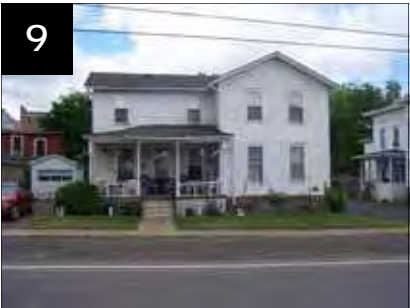
Apartments, 6189-6191 SR 21
Landscaping: Good
Façade/Structure: Fair, Wood
Signage: None
Sidewalk: Fair, 4’ concrete
Notes: Sagging porch, circa 1860 Vernacular house.

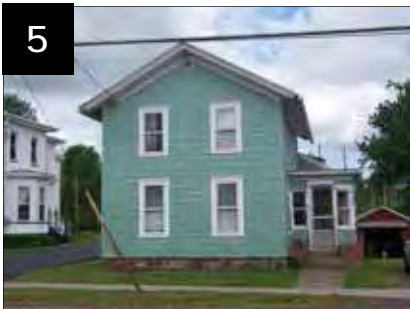
Residence, 6143 SR 21
Landscaping: Fair
Façade/Structure: Fair, Wood shake
Signage: None
Sidewalk: Good, 4’ concrete
Notes: Circa 1860 Vernacular house.

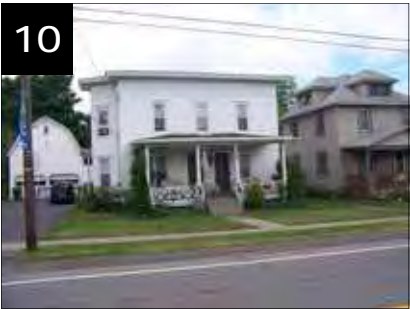
Residence, 6195 SR 21
Landscaping: Good
Façade/Structure: Good, Wood
Signage: None
Sidewalk: Good, 4’ concrete
Notes: Circa 1870 hip-roof Italianate house.

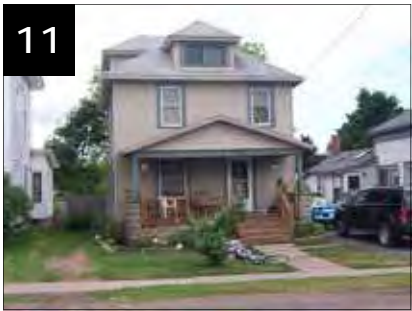
Residence, 6197 SR 21
Landscaping: Fair
Façade/Structure: Good, Wood
Signage: None
Sidewalk: Good, 4' concrete
Notes: Circa 1905 hour-square house.

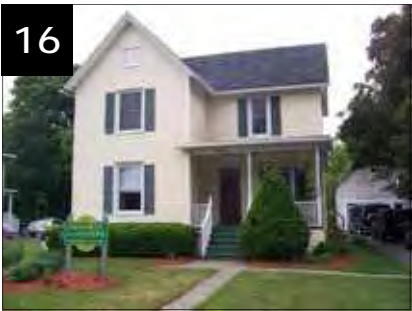
Elizabeth Sammons-Atty., 6216 SR 21
Landscaping: Good
Façade/Structure: Good, Vinyl
Signage: Good, Freestanding
Sidewalk: Good, 4' concrete
Notes: Circa 1890 Vernacular tri-gable house/business.

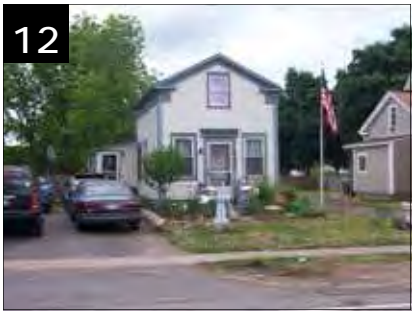
Residence, 6199 SR 21
Landscaping: Good
Façade/Structure: Good, Wood
Signage: None
Sidewalk: Good, 4' concrete
Notes: Lawn in ROW is bare/patchy, circa 1835 small 1.5 story Greek revival house.

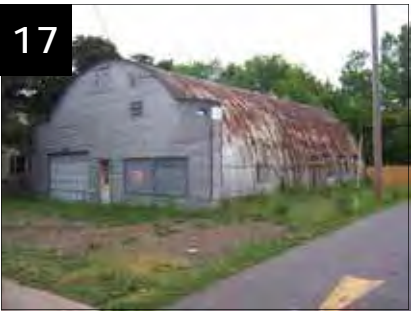
Vacant garage, 6210 SR 21
Landscaping: None
Façade/Structure: Poor, metal
Signage: None
Sidewalk: Good, 4' concrete
Notes: Vacant auto repair facility, circa 1945 Quonset barn.

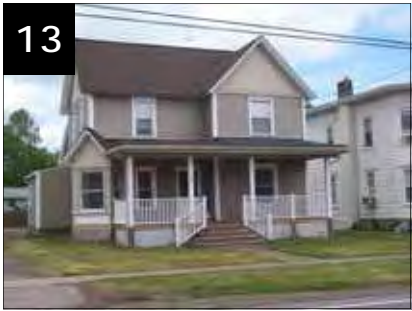
Residence, 6205 SR 21
Landscaping: Fair
Façade/Structure: Good, Vinyl
Signage: None
Sidewalk: Good, 4' concrete
Notes: Circa 1895 Queen Anne house.

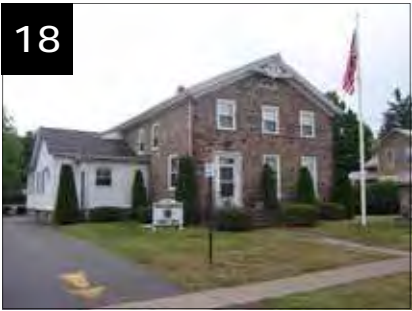
American Legion (Post 394), 6206 SR 21
Landscaping: Good
Façade/Structure: Good, Cobble/vinyl
Signage: Good, changeable type/freestanding
Sidewalk: Good, 4' concrete
Notes: Changeable type sign is weathered but still legible, circa 1830 Federal random-covered ashcar house.

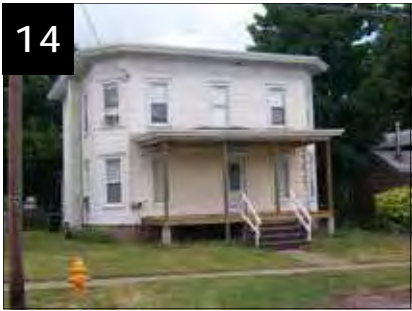
Residence, address unknown
Landscaping: Fair
Façade/Structure: Fair, Wood
Signage: None
Sidewalk: Good, 4' concrete
Notes: Building appears to be in adequate shape, porch incomplete, circa 1870 Italianate house.

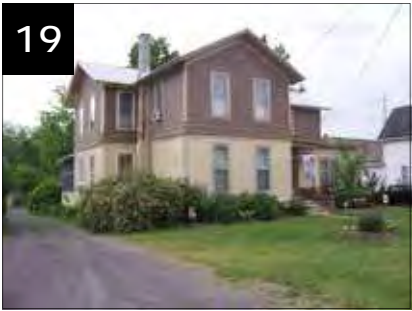
Residence, 6198 SR 21
Landscaping: None
Façade/Structure: Good, Wood shake
Signage: None
Sidewalk: Good, 4' concrete
Notes: Circa 1875 cross-plan Vernacular house.

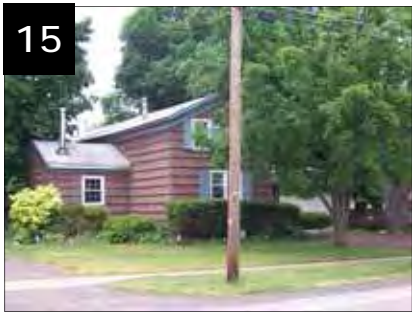
Residence, address unknown
Landscaping: Good
Façade/Structure: Good, Wood
Signage: None
Sidewalk: Good, 4' concrete
Notes: Large tree partially blocking front of house, circa 1840 Greek revival with 20th century alterations.

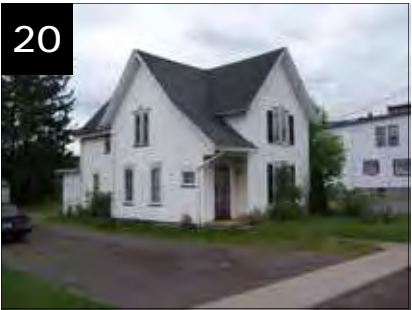
Residence, 6194 SR 21
Landscaping: Poor
Façade/Structure: Fair, Vinyl
Signage: None
Sidewalk: Good, 4' concrete
Notes: Building looks vacant, circa 1880 Gothic revival house.

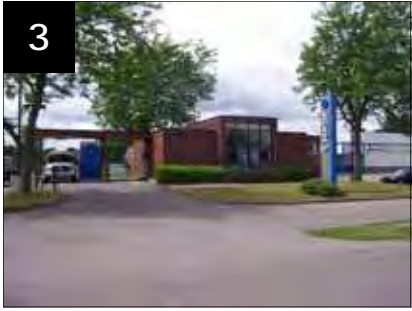
Chase Bank
Landscaping: Good
Façade/Structure: Good, Brick
Signage: Good, 1 freestanding & wall
Sidewalk: Good, 4-6' concrete
Notes: Typical building design, internal and Route 104 sidewalk.

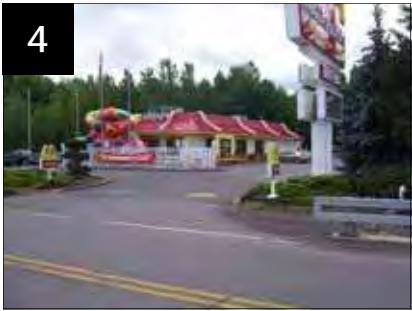
McDonald's
Landscaping: Good
Façade/Structure: Fair, Concrete block
Signage: Fair, multiple lit signs
Sidewalk: Good, 6' concrete
Notes: Internal sidewalk only, typical building design, playground blocks front.

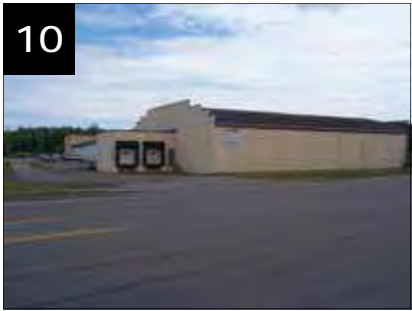
Thatcher Company, 4135 Ridge Rd
Landscaping: None
Façade/Structure: Fair, Concrete block
Signage: Poor, 1 painted wall sign
Sidewalk: Fair, 6' concrete
Notes: No building details or windows, sign is very small—hard to read from road, partial sidewalk on east end, unknown if occupied or vacant.

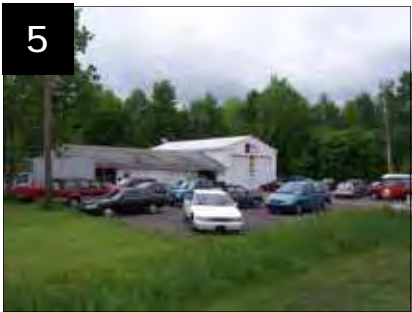
Henner Automotive
Landscaping: Fair
Façade/Structure: Fair, Concrete block
Signage: Good, 1 wall sign
Sidewalk: None
Notes: Building and addition inconsistent, some maintenance to roof, large lot of cars located in front.

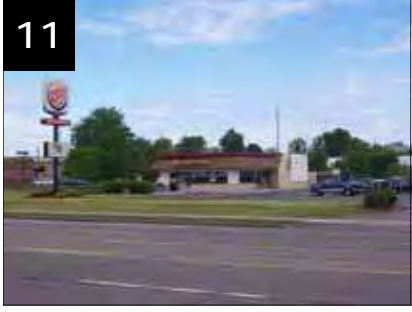
Burger King
Landscaping: Good
Façade/Structure: Good, Brick/concrete
Signage: Fair, 2 wall signs—1 pole sign
Sidewalk: Good, 6' concrete
Notes: Typical building design, well maintained lot, large signage.

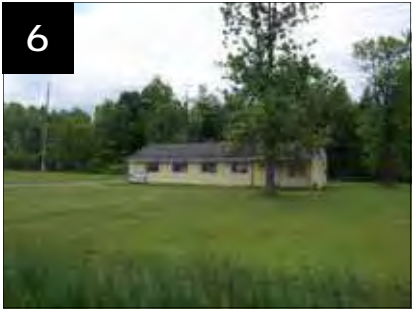
Vacant building
Landscaping: None
Façade/Structure: Fair, Concrete block
Signage: None
Sidewalk: None
Notes: Lawn is maintained, windows need repair, former printing company?

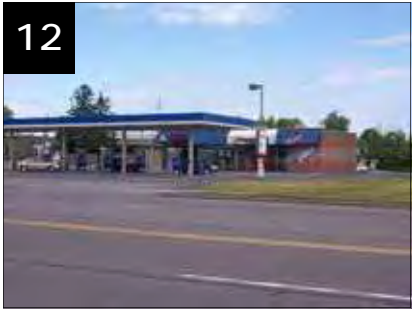
Mobil Gas/Express Mart
Landscaping: Fair
Façade/Structure: Good
Signage: Fair, wall and pole signs
Sidewalk: Good, 6' concrete
Notes: Typical store layout/design, grass only—no landscaping, no building details, large parking lot along frontage.

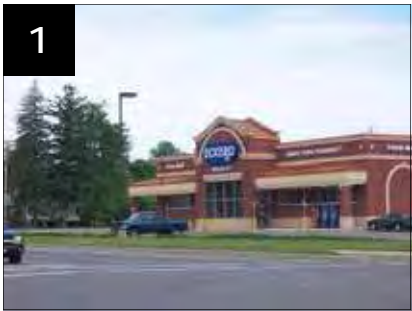
Rite Aid Drugstore
Landscaping: Fair
Façade/Structure: Good, Brick
Signage: Good, 1 lighted wall sign
Sidewalk: Good, 6' concrete
Notes: Parking lot located at front, typical store design and layout, few plantings.

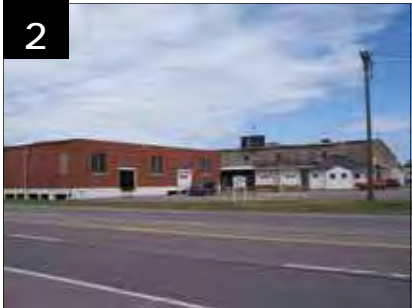
Williamson Cold Storage, 4009 SR 104
Landscaping: None
Façade/Structure: Fair, various materials
Signage: Good, 1 freestanding sign
Sidewalk: None
Notes: Large storage building, no details/windows, large open storage at rear.

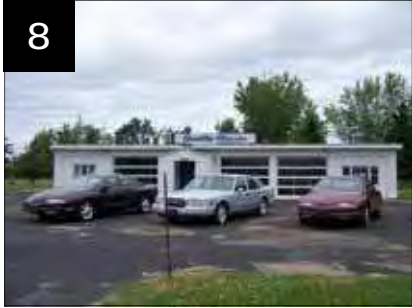
Quality Classics, 3865 SR 104
Landscaping: Poor
Façade/Structure: Fair, Concrete block
Signage: Good, 1 roof sign
Sidewalk: None
Notes: Building appears underutilized, few cars for sale, no clear indication of a sustaining business.

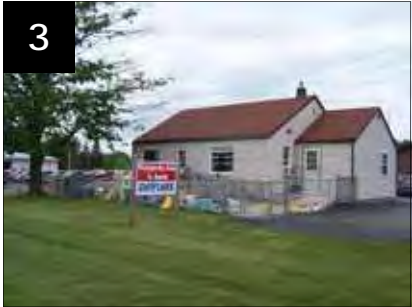
Raggedy Ann & Andy Daycare, 955 SR 104
Landscaping: Fair
Façade/Structure: Good, Vinyl
Signage: Good, 1 freestanding & window
Sidewalk: None
Notes: Playground along road frontage, no building details, window sign hard to read.

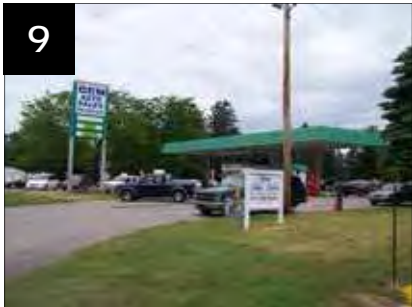
Gem Auto Sales
Landscaping: Fair
Façade/Structure: Fair, concrete block
Signage: Good, multiple
Sidewalk: None
Notes: Former gas station. Many signs for a small business/structure, but legible from street.

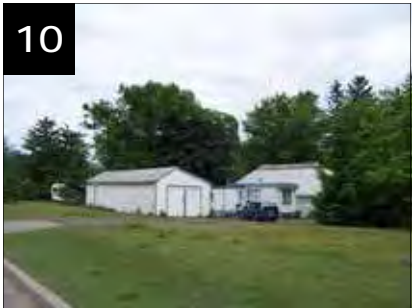
Residence
Landscaping: Fair
Façade/Structure: Fair, Wood/Vinyl
Signage: None
Sidewalk: None
Notes: Unknown where primary structure is—multiple buildings on site. Garage is located along frontage, mobile home behind.

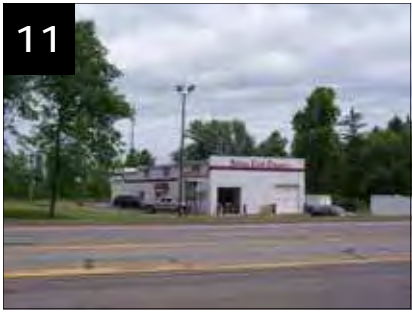
Salmon Creek Cabinetry
Landscaping: Fair
Façade/Structure: Good, Concrete block
Signage: Good, Wall and freestanding sign
Sidewalk: None
Notes: Blank façade with garage doors, windows and entrance located on side of structure.

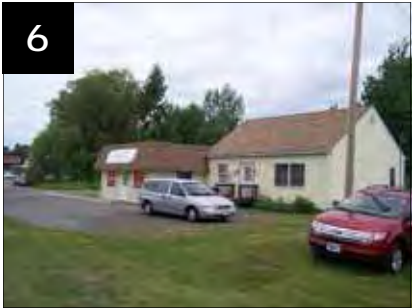
Residence & Vacant building 3895-3901 SR 104
Landscaping: Fair
Façade/Structure: Fair, Vinyl
Signage: Poor, 1 roof sign
Sidewalk: None
Notes: Store front has few windows, no features, sign is faded, attached to house. Gravel lot in front and side.

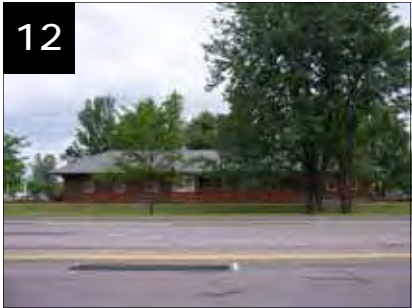
Depot Professional Bldg
Landscaping: Good
Façade/Structure: Good, Wood siding
Signage: Good, freestanding
Sidewalk: None
Notes: Style of old train depot, well kept, few design details.

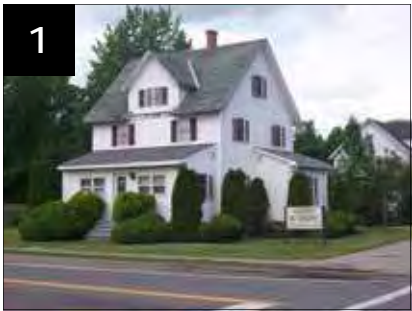
Grow & Grow Attorneys
Landscaping: Good
Façade/Structure: Good, Wood siding
Signage: Good, multiple signs
Sidewalk: Good, 4-6' concrete
Notes: Roof appears to need some work, window/wall/freestanding signage.

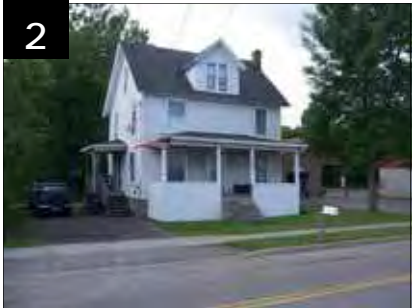
Residence, 4066 Ridgeway St.
Landscaping: Fair
Façade/Structure: Good, wood siding
Signage: None
Sidewalk: Good, 4' concrete
Notes: None

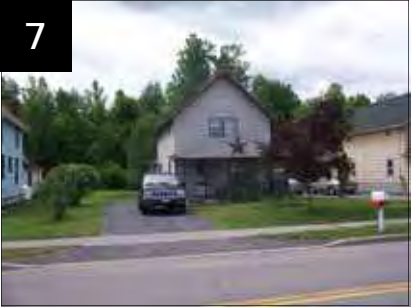
Residence, 4024 Ridgeway St.
Landscaping: Good
Façade/Structure: Good, Wood siding
Signage: None
Sidewalk: Good, 4' concrete
Notes: None

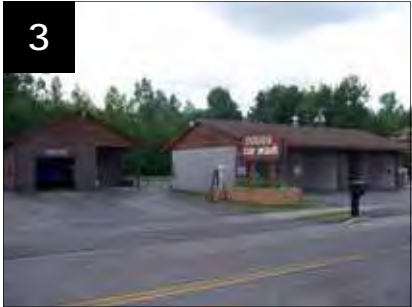
Doug's Car Wash
Landscaping: Fair
Façade/Structure: Good, Block/wood
Signage: Good, 2 freestanding
Sidewalk: Good, 4' concrete
Notes: No building details, only landscap- ing around signage, well maintained lot & building.

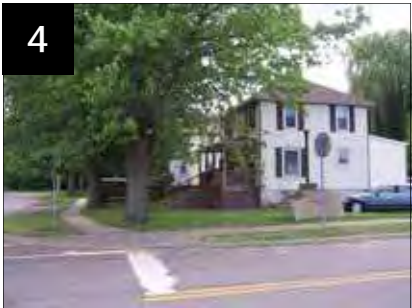
Residence, Ridgeway/Cole St
Landscaping: Fair
Façade/Structure: Good, wood siding
Signage: None
Sidewalk: Good, 4' concrete
Notes: Maintained lawn, large tree in front, dilapidated garage located at rear of house along Ridgeway St.

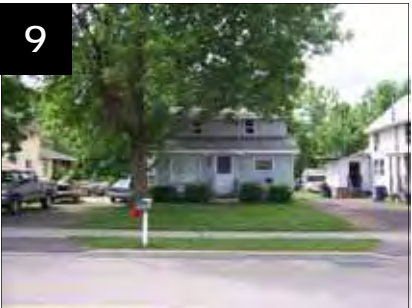
Residence, 4014 Ridgeway St.
Landscaping: Good
Façade/Structure: Good, Vinyl
Signage: None
Sidewalk: Good, 4' concrete
Notes: Large tree partially blocking front.

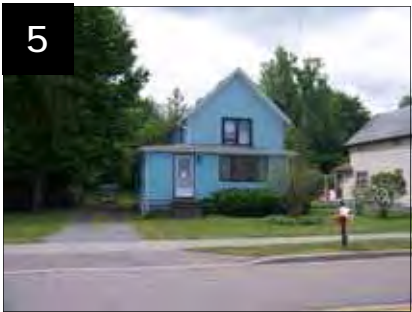
Residence, 4028 Ridgeway St
Landscaping: Good
Façade/Structure: Fair, wood siding
Signage: None
Sidewalk: 4' concrete
Notes: None
