Town of Williamson

Route 21 & 104 Gateway Study

Final Report

July 2008

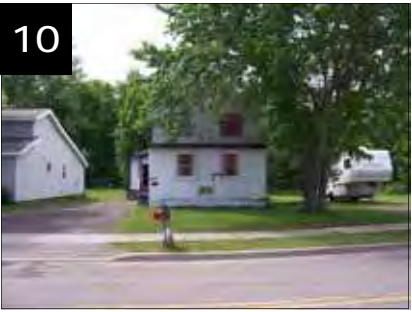
Residence, 4010 Ridgeway St.
Landscaping: Fair
Façade/Structure: Fair, various materials
Signage: None
Sidewalk: Good, 4' concrete
Notes: Porch does not match original house materials, weathered façade, lawn maintained.

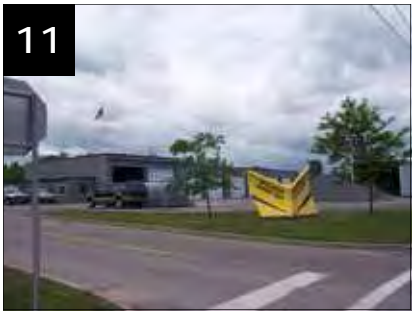
Williamson Highway Department
Landscaping: Fair
Façade/Structure: Good, Concrete block
Signage: Good, wall and decorative sign
Sidewalk: Good, 4-6' concrete
Notes: No façade design features, also a large salt/sand barn located at the rear of the building.

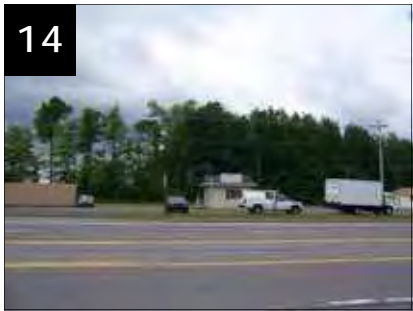
Vacant auto sales lot
Landscaping: Fair
Façade/Structure: Fair, concrete block
Signage: Poor, roof sign
Sidewalk: None
Notes: Appears vacant, random cars parked in lot, roof sign is blank, small building with no features

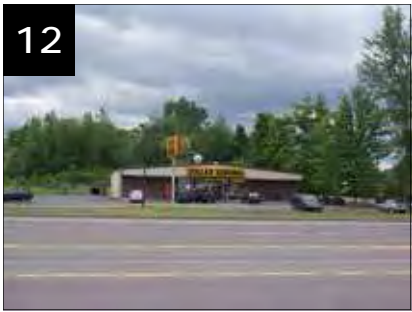
Dollar General
Landscaping: Fair
Façade/Structure: Fair, Concrete block
Signage: Good, Lighted pole and wall sign
Sidewalk: None
Notes: Typical design, no façade design features, parking lot at front, few windows.

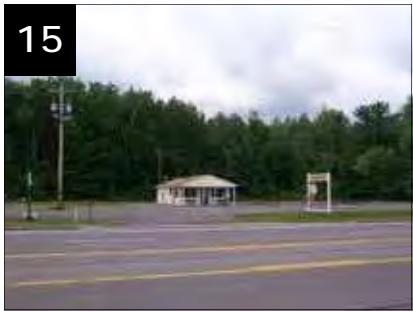
Sundaze Ice Cream Shop
Landscaping: None
Façade/Structure: Good, Vinyl
Signage: Good, freestanding
Sidewalk: None
Notes: Majority of lot appears to be a gravel lot, possibly a seasonal use - currently not open for season.

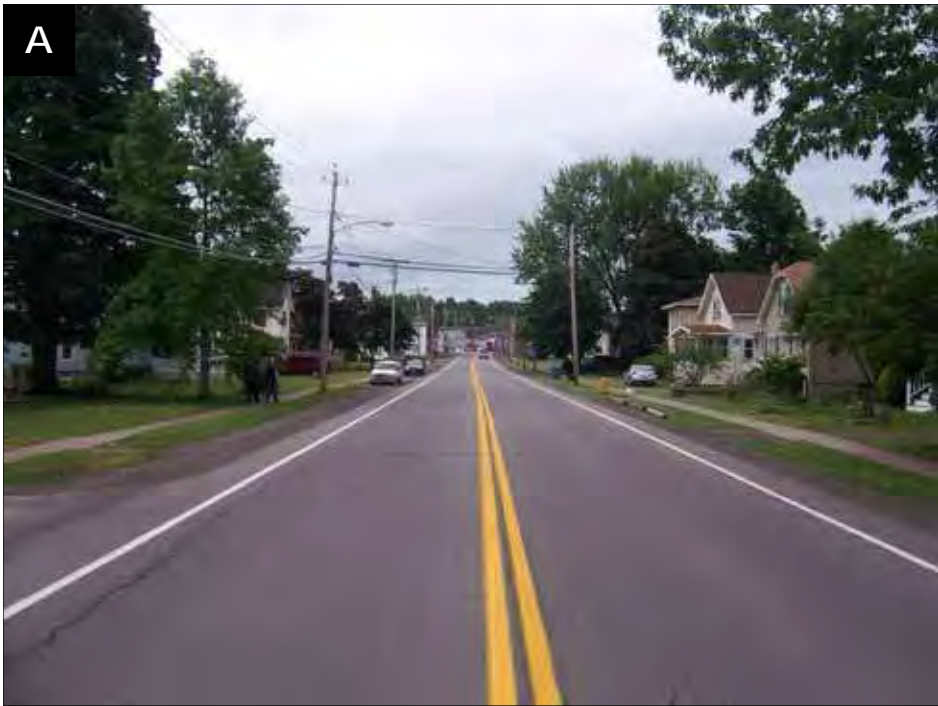
North bound State Route 21 @ Circle Drive
Corridor Design: Fair
Pedestrian Connectivity: Good
Wayfinding Ability: Poor
Notes: Most of the structures in the corridor are wood or wood-simulated vinyl. The only area lacking sidewalks is at the west side of the Williamson Hardware building. There are no wayfinding signs in this area; only town banners are observed on some light poles closer to the hamlet.

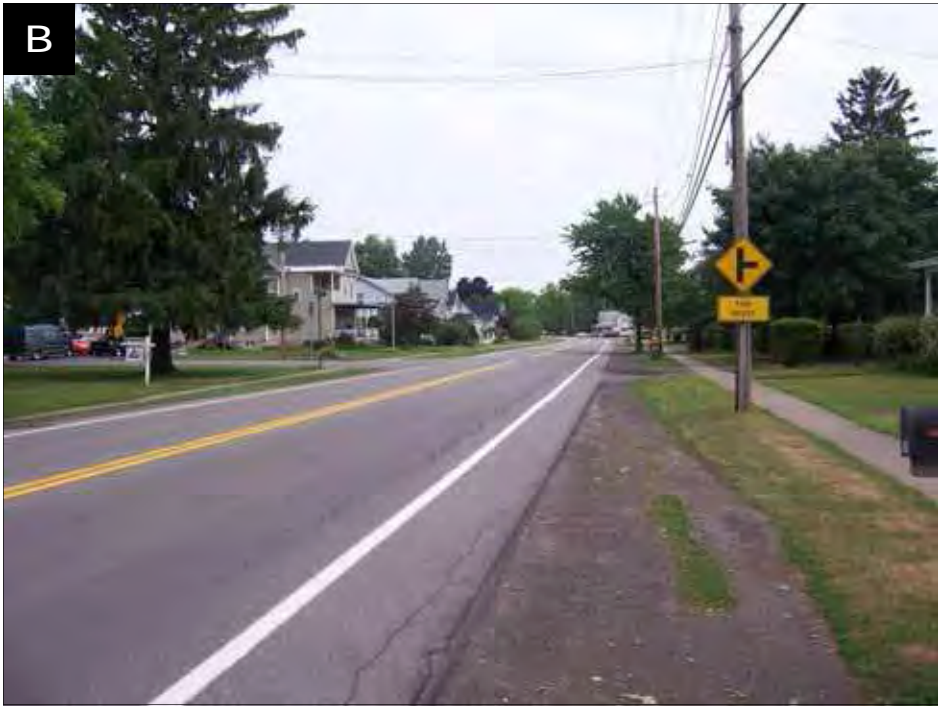
North bound State Route 21 @ Circle Drive
Corridor Design: Good
Pedestrian Connectivity: Good
Wayfinding Ability: Poor
Notes: Most of the structures in the corridor are wood or wood-simulated vinyl and are constructed with the gable end facing the street. Town banners are located on some light poles closer to the hamlet.

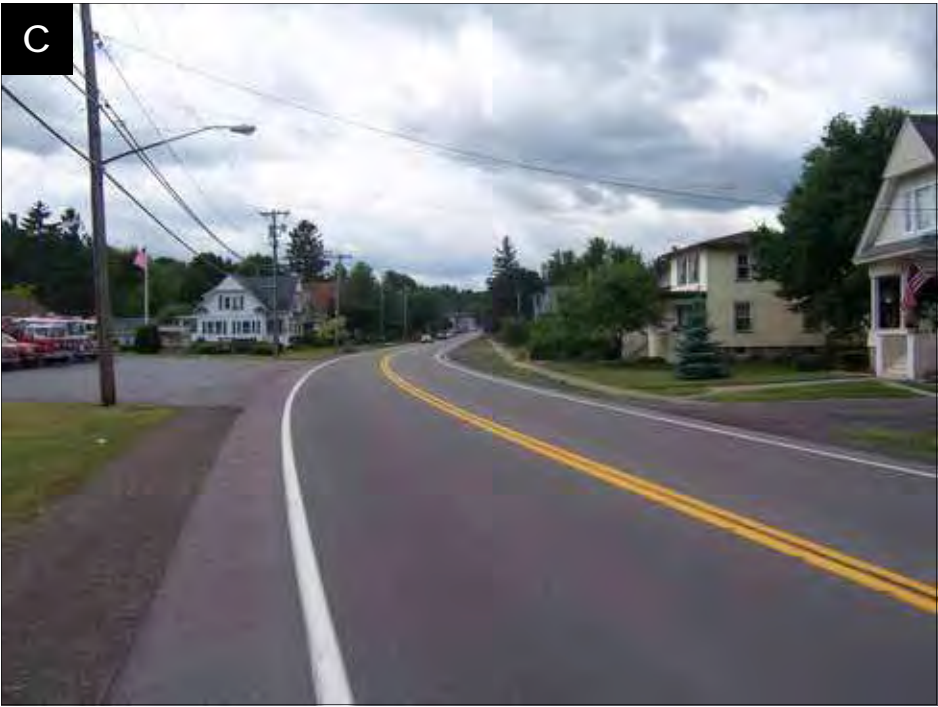
North bound State Route 21 @ Circle Drive
Corridor Design: Good
Pedestrian Connectivity: Fair
Wayfinding Ability: Poor
Notes: The sidewalks are continuous on the west side of Route 21, but end on the east side at the fire department and the house just north of the F.D.

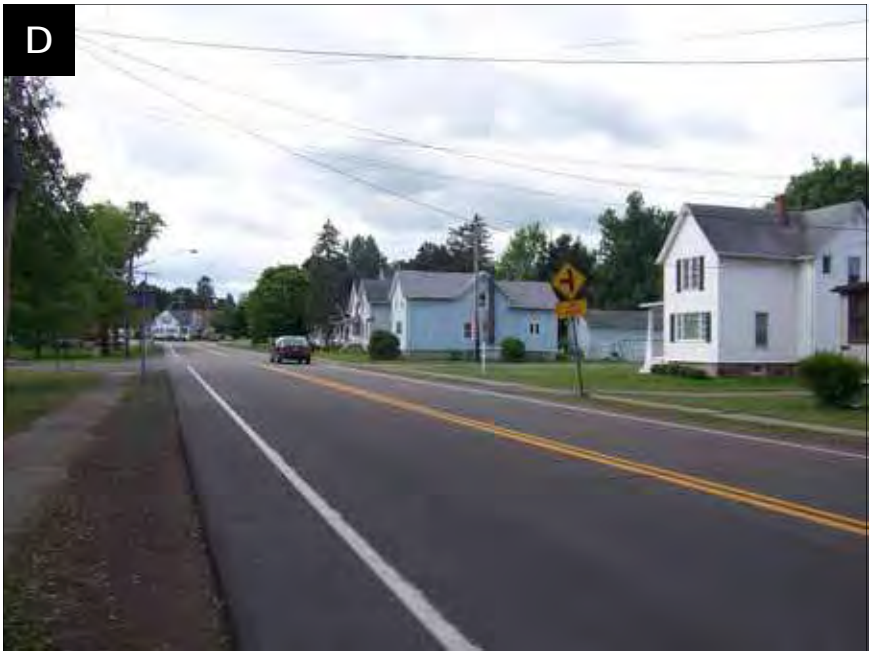
South bound State Route 21 @ Wayne Street/Arrowbend Drive
Corridor Design: Fair
Pedestrian Connectivity: Good
Wayfinding Ability: Poor
Notes: Single family homes continue on the west side, while higher density apartments are found on the opposite side. No sidewalk exists at the south end of Arrowbend Drive.

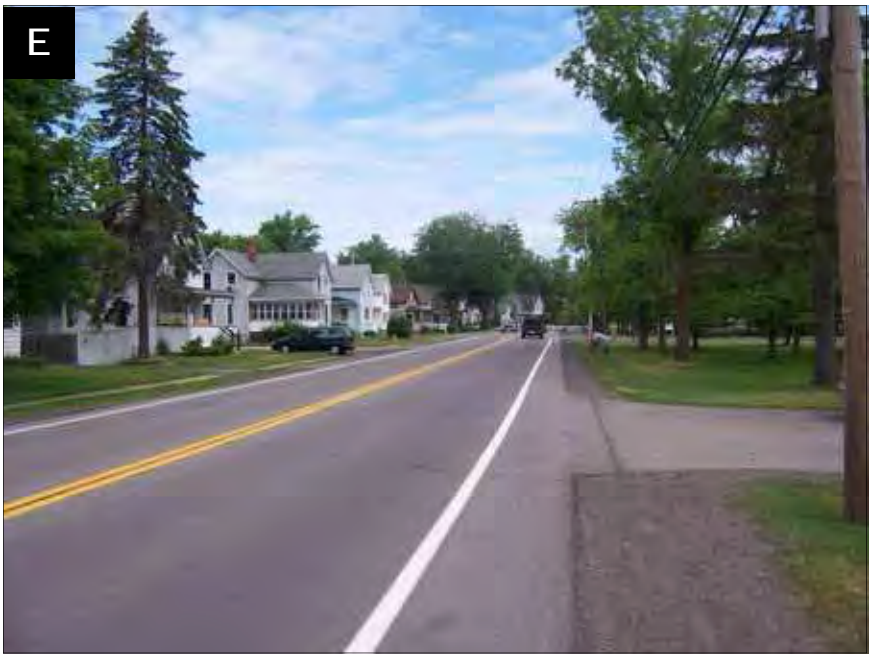
North bound State Route 21 @ Rasmussen Street
Corridor Design: Fair
Pedestrian Connectivity: Fair
Wayfinding Ability: Poor
Notes: The single family homes become less prominent past Rasmussen St. Sidewalk is missing between the fire station and Arrowbend Drive.

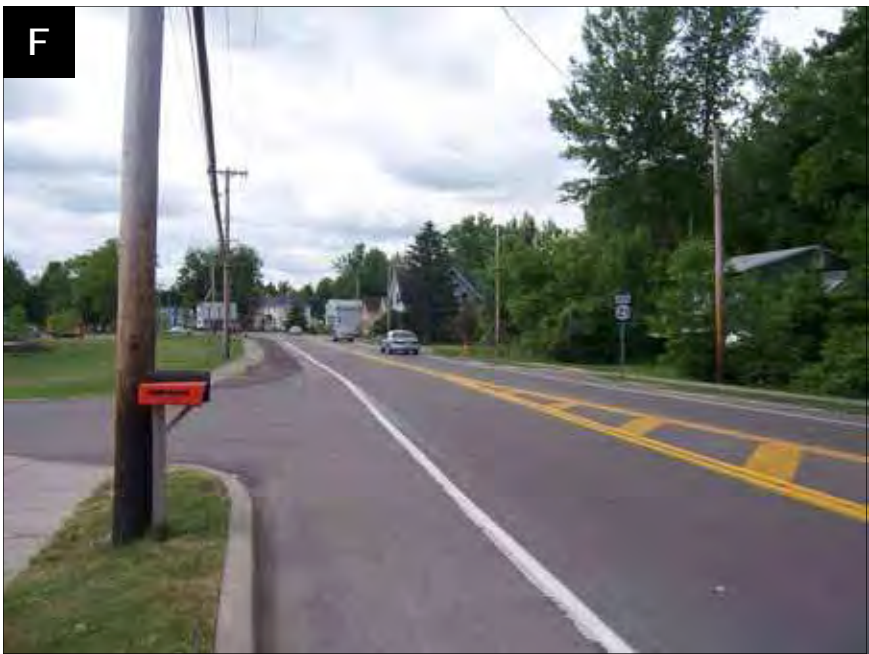
South bound State Route 21 @ south end of IGA parcel
Corridor Design: Fair
Pedestrian Connectivity: Good
Wayfinding Ability: Poor
Notes: This area is more of a transition point between the single family homes and the highway commercial style of development.

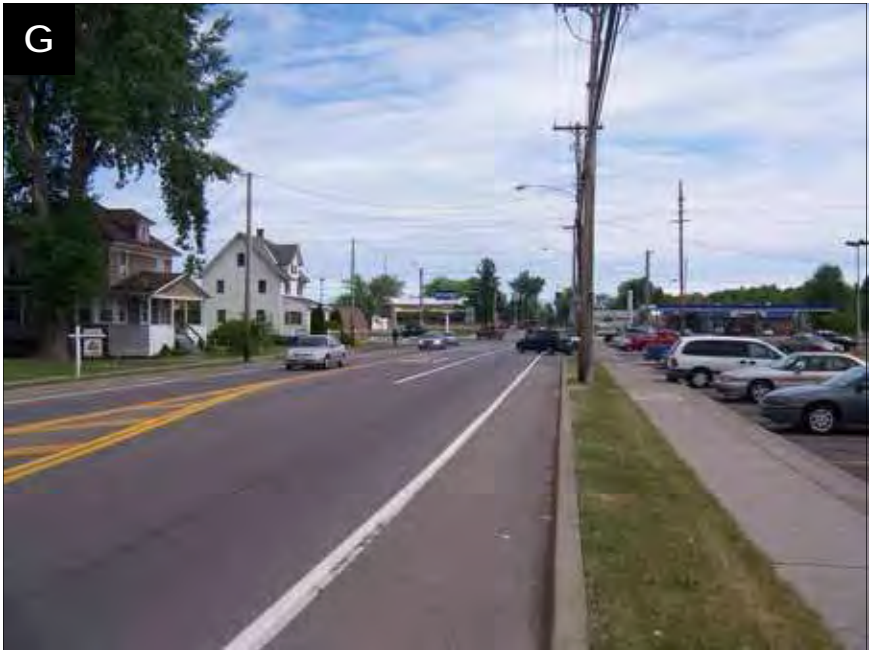
North bound State Route 21 @ north end of IGA parcel
Corridor Design: Poor
Pedestrian Connectivity: Good
Wayfinding Ability: Poor
Notes: The few single family homes on the west side of Route 21 are for sale or are in poor shape. The house on the southwest corner of Routes 21 & 104 is a business. Breen's IGA takes up the east side of this section.

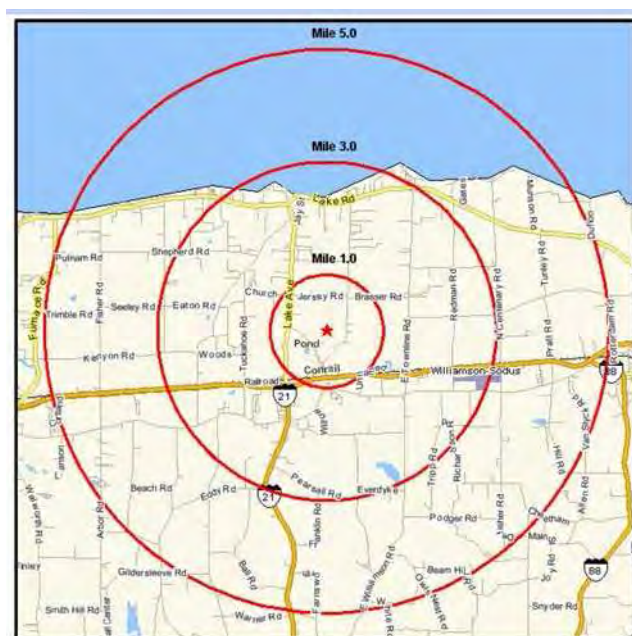
To examine local spending patterns we selected a point east of State Route 21 and south of Jersey Roads as the approximate center point of our study area. Three radii were chosen to capture activity of households in the vicinity of the study area. Market Area I consists of households located within a one-mile radius of the center point. Market Area II captures households located in the one- to three-mile radius. And Market Area III included households located in the three- to five-mile radius. Given the size of the community and its location, it was reasonable to assume that this distance would adequately capture the Town of Williamson's local market. Residents outside of these three market areas would likely have their local shopping needs met elsewhere.

Figure 1: Market analysis study area.
