Monroe County Department of Transportation

Vertical Curve Safety Study

Monroe County, New York

1.0 Executive Summary

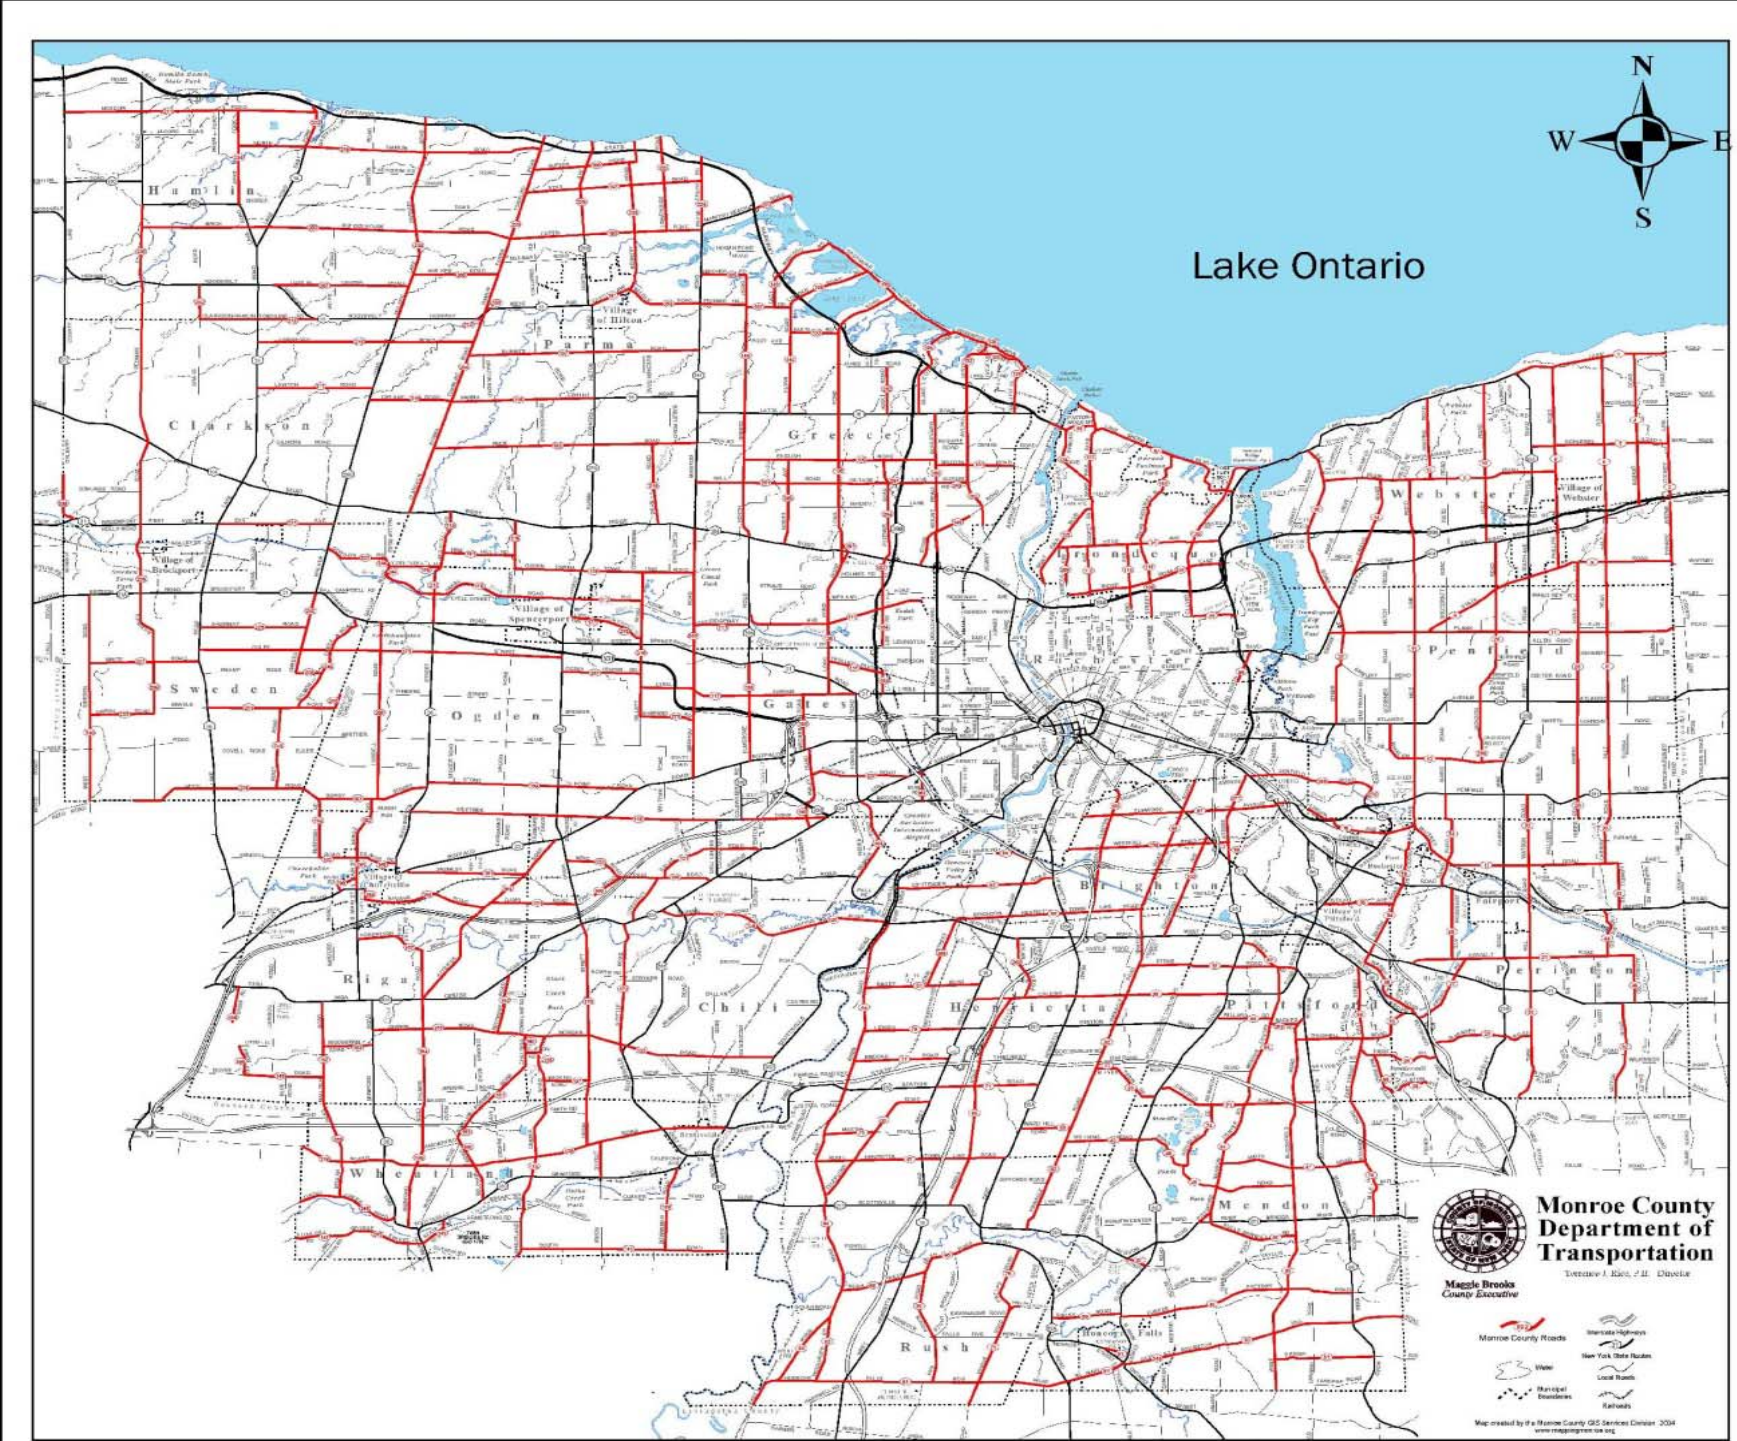
FIGURE ES-1
Monroe County DOT
Vertical Curve Safety Study
Project Study Area

The overall project study area included all County Route roadways and intersections within Monroe County. **Figure ES-1** identifies the roadways studied.

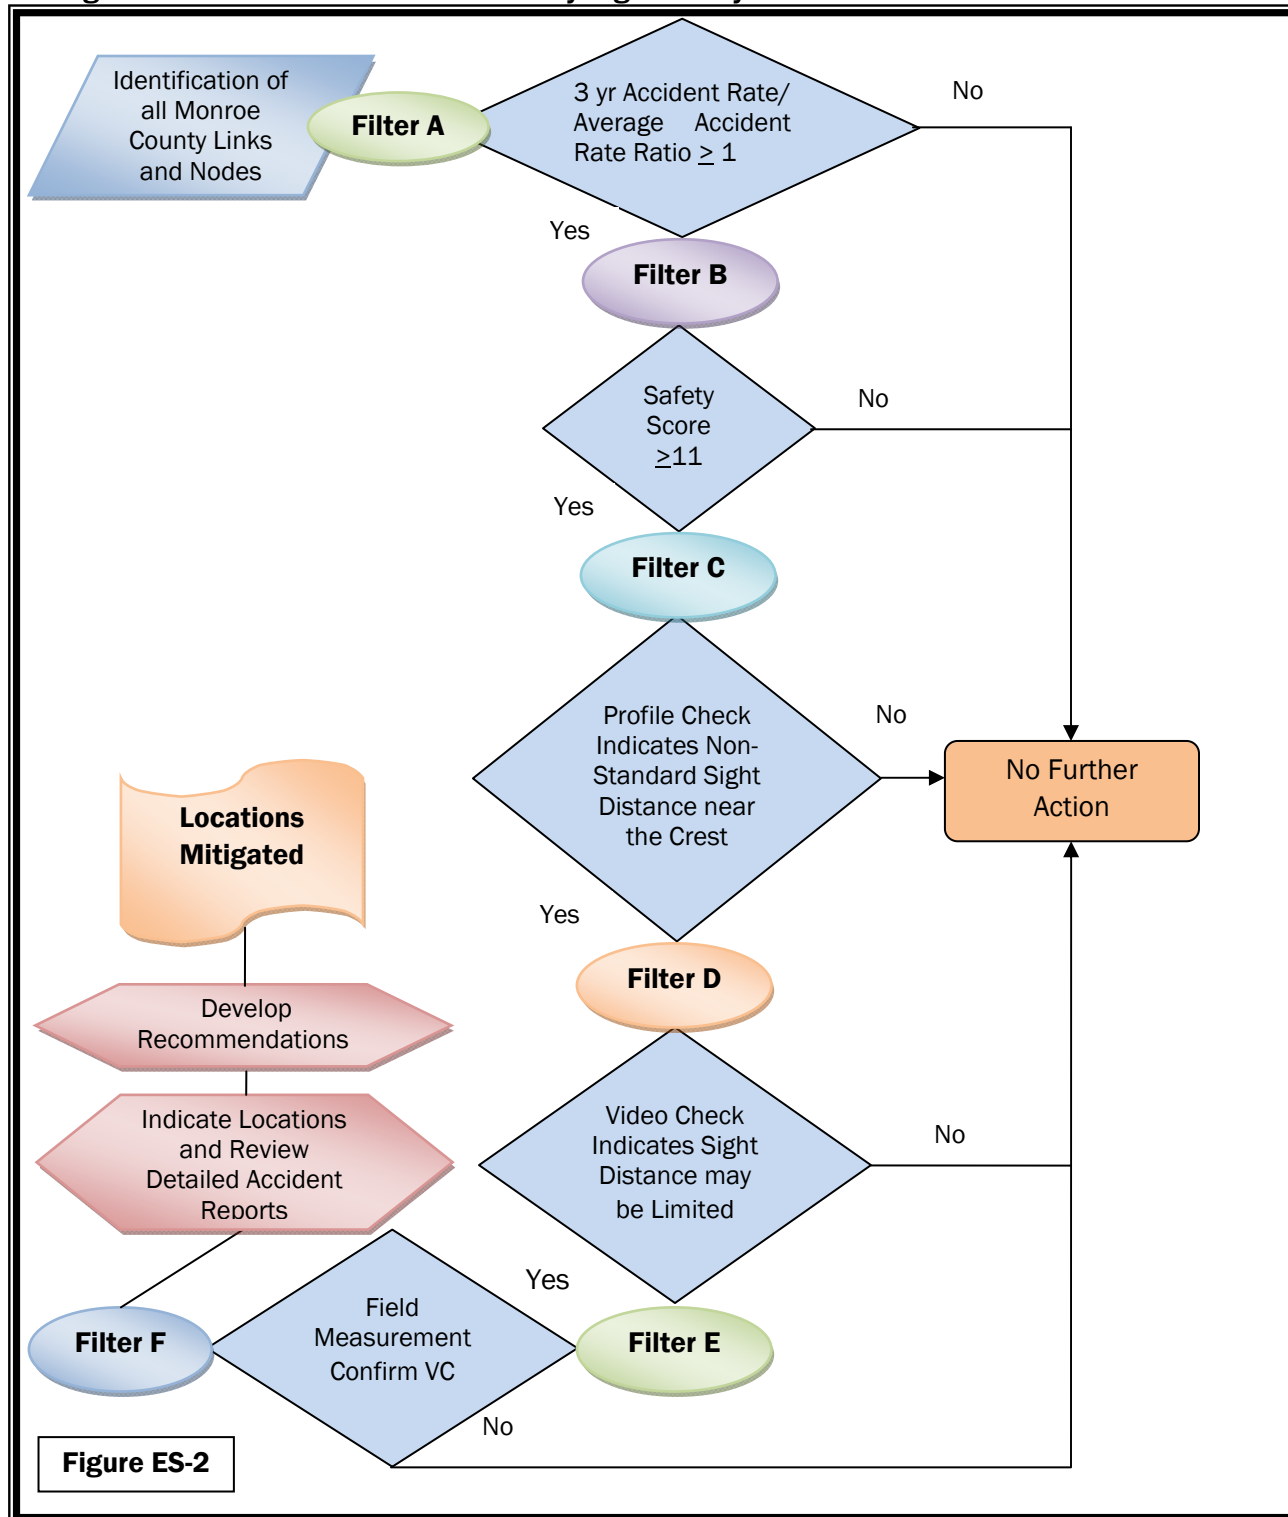
Figure ES-2 – Filter Flowchart to Identify High Priority Candidate Vertical Curve Locations

The steps taken to complete the project analysis are previewed below and identified in **Figure ES-2**. A predetermined series of Filters was used to pinpoint the High priority Candidate Vertical Curve Locations that were recommended for mitigation. A brief description of each filter is summarized below; further discussion follows within the text of this section.

The process used to complete the project analysis is illustrated in **Figure ES-2**.

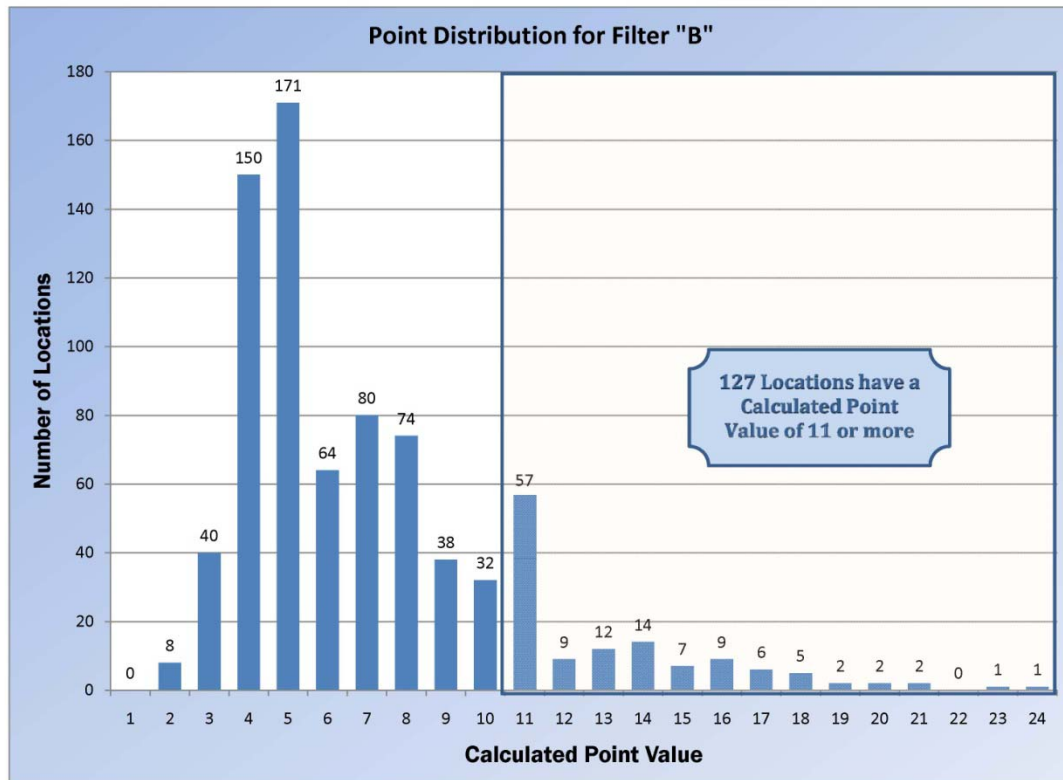
Figure ES-4 – “Filter B” Vertical Curve Point Distribution

5. A point system was developed considering the accidents, volume, speed and estimated sight distance. The total point value was evaluated for each location identified within this filter and sorted from highest to lowest. A total of **127** locations were identified with a safety score of eleven (11) or greater and, based on statistical analysis significance, were progressed to the next level (Filter C). **Figure ES-3** outlines the point determinations scale used to determine the overall scores. Refer to **Figure ES-4** for a breakdown of the total number of locations based on the overall total score value.

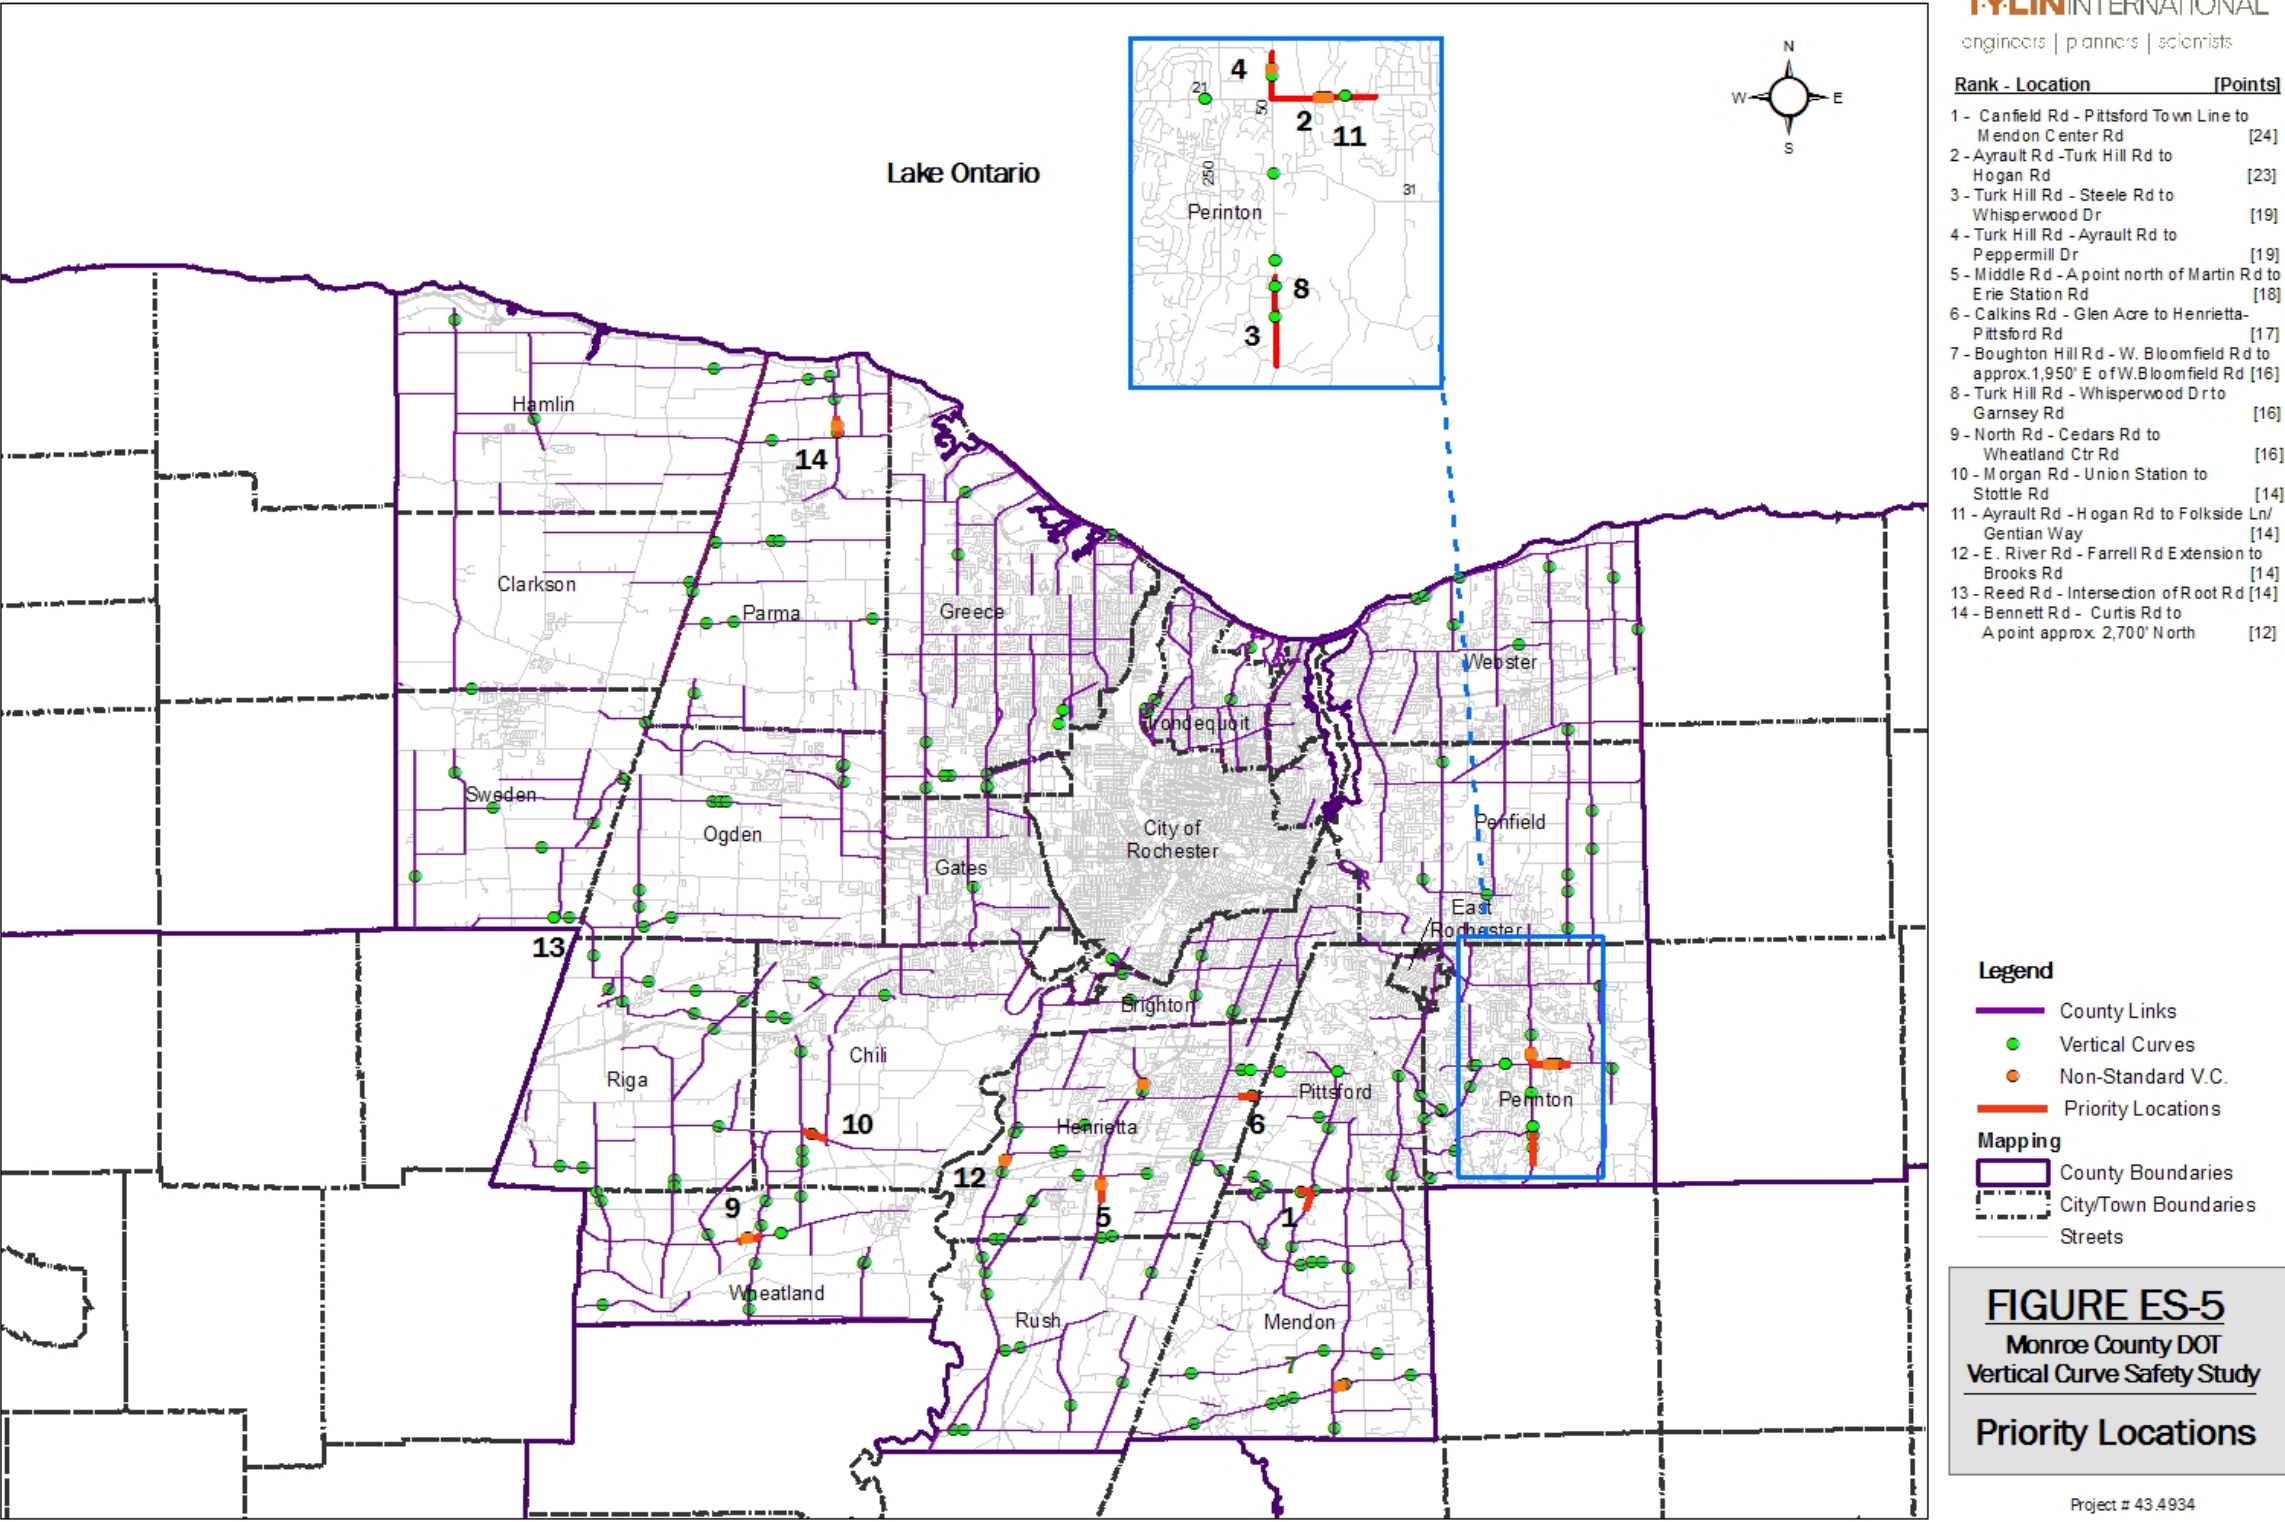
Each candidate vertical curve location recommended for remediation through this filter was plotted on a GIS map to identify cluster locations and recommend mitigation measures to improve safety at the vertical curve. **Figure ES-5** illustrates clusters of vertical curve locations with respect to the overall vertical curve locations identified in the beginning of this study. A majority of the High Priority Candidate Vertical Curve Locations recommended for mitigation are located on the southeast side of Monroe County in eight different towns.

Figure ES-5 includes a list of the **14** candidate vertical curve locations rated from highest priority to lowest priority based on the total overall score. Information pertaining to the road name and the location of the vertical curve are reported in this table.
