# ROADWAY SAFETY AND WALKABILITY AUDIT

The primary objectives of this document are to present the findings of roadway safety audits conducted for the Town of Pavilion as well as to identify potential physical improvements and policies to support roadway safety for all users within the Hamlet portion of the Town. The planning process described combines data analysis, survey, and stakeholder discussion to strengthen the resultant recommendations. GTC's Long Range Transportation Plan 2045 identifies a suite of recommendations under the health and safety umbrella to ensure that transportation facilities are designed for all users and provide self-enforcing cues to users regarding safe operation within the system. This effort seeks to moderate traffic conditions to improve safety of operations for all transportation system users, with emphasis on school-related activity, and support conditions more favorable to economic development.

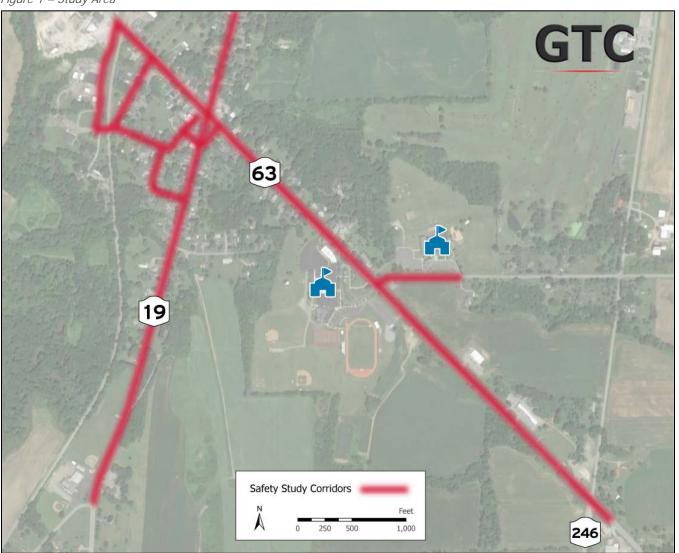
Figure 1 – Study Area

The study area has been expanded from the Town's original UPWP application to include all roadways within the hamlet. Sections of York Road and an extended section of Lake Street (Route 19) are included to examine access to the Elementary School and Pavilion Fire Department/Rec Hall/Babe Ruth League community destinations.

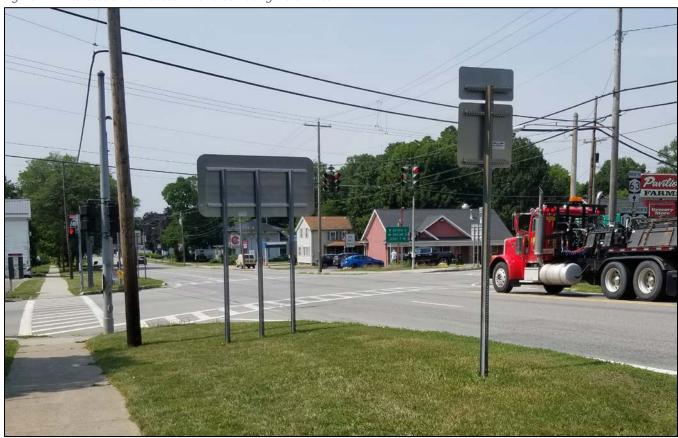
Initial discussion centered on the Hamlet's primary four-way intersection where State Routes 63 and 19 cross. Issues noted by committee members included signal timing and the large traffic imbalance between the two routes. The pedestrian fatality cited in the crash analysis was mentioned. Business destinations at the center of the Hamlet are not considered to induce the traffic volumes observed.

Route 19 does not follow an original roadway alignment, and in fact bisects the traditional town square. Restoration of the square, however, would not have an impact on the greater issue, that of Route 63 cut-through freight traffic. Initial observations of southeast-bound Route 63 noted an additional lane for which removal could be analyzed. Concerns were expressed regarding possible queuing impact of southeast-bound freight traffic if lanes were removed.

- Evaluate reducing the number of Route 63 southeast-bound lanes from two to one between Route 19 and York Road
- Evaluate the warrants for a traffic signal at Route 63 and York Road intersection
- Install a school zone sign with flashing beacon, but without further speed limit reduction
- Deploy mobile speed indicators at multiple locations near the schools
- Conduct a sidewalk surface condition assessment and rehabilitate existing sidewalks in need of change
- Add sidewalks where they are desired, but not currently present
- Install pedestrian scale lighting along sidewalks
- Plant street trees in sidewalk buffers where they are not currently present

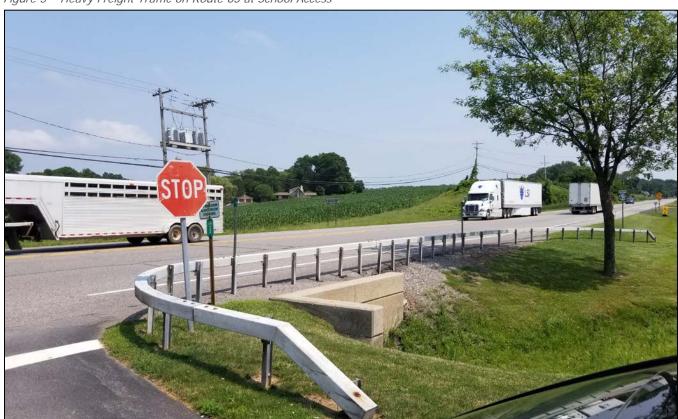
The second and most notable location discussed was the intersection of Route 63, York Road, and the Pavilion Central Schools bus access. In addition to the High School situated immediately west of this intersection, the district elementary school is located just east of the intersection on the north side of York Road. Fundamental issues involve the ability of school buses to safely exit the high school grounds and the stacking of vehicles belonging to the parents of elementary school students on York Road at arrival and dismissal.

The issues are exacerbated by the merging of the two southeast-bound lanes at a point immediately after the intersection, leading to undesirable driver behavior in an effort to change lanes at the last opportunity. The speed of heavy freight traffic heightens concerns regarding school bus safety. The area lies completely within a 35-mph speed limit zone, but often requires active patrol by the Genesee County Sheriff's Department to improve driver compliance.

From the center of the Hamlet to just southeast of York Road, Route 63 features two southeast-bound travel lanes intended to allow vehicles to pass slower traffic travelling uphill. Previous observations note that the merging of these lanes immediately after the York Road intersection contributes greatly to perceived safety issues related to school transportation operations. While concerns about vehicle queuing on Route 63 are noted, removal of the additional lane as part of a roadway reconfiguration may realize the following benefits:

The intersection of Route 63, York Road, and Pavilion Central School District's school bus access is currently unsignalized. The Project Advisory Committee suggested a traffic signal to control traffic speeds and flow at the main High School access point during peak campus egress. To realize a traffic signal at this intersection, it should be evaluated per the Manual of Uniform Traffic Control Devices (MUTCD) to determine if it meets warrants for signalization.
