**NYS Department of Transportation**

# NYSDOT Safety Investigations (UPWP #6232) HIGHWAY SAFETY INVESTIGATIONS REPORT

December 2020

# Brighton-Henrietta Townline Road

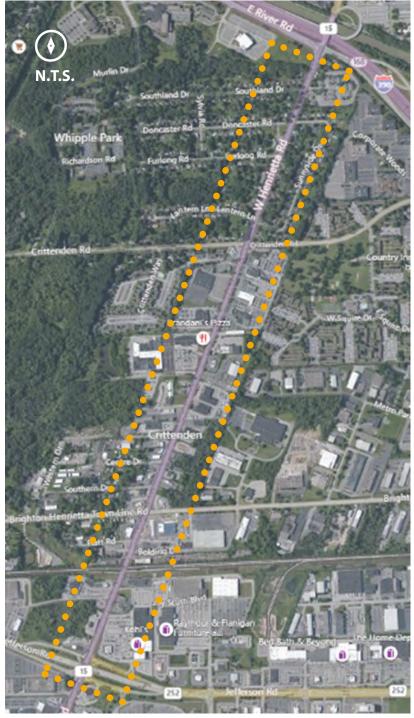
Figure 1: West Henrietta Road Study Area (source: Bing Maps)

# West Henrietta Road (Route 15)

- 1.7-mile multi lane Urban Arterial
- Residential and Commercial Access
- Mixture of Signalized and Unsignalized Intersections
- Characterized by closely spaced commercial driveways, non-continuous sidewalk, and several transit stops.

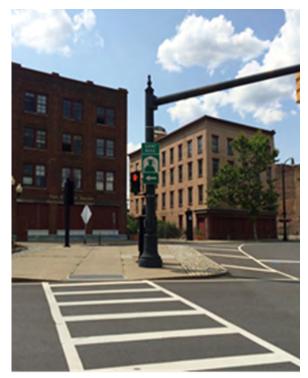
**Example Pedestrian Facilities**

Safety enhancements to provide a safer experience for vulnerable users such as pedestrians and bicyclists include improvements to the ped/bike network along the corridor to provide enhanced connectivity as well as establishing a continuous ADA accessible route per the guidance of the NYS Pedestrian Safety Action Plan.

- Improve sidewalk networks, corridor lighting, and consider bicycle facilities per the most recent AASHTO guidance
- Upgrade pedestrian facilities to include hiviability crosswalks and pedestrian signals
- Evaluate the location of transit stops to support the Reimagine RTS Route 14 as well as RIT and U of R services

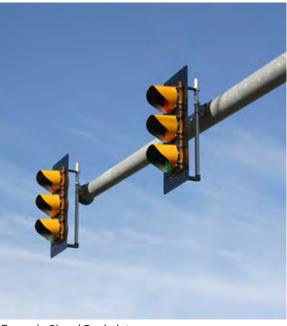
Example Signal Backplates

Intersections safety enhancements include both infrastructure and traffic signal improvements to address crash patterns such as rear end, left turns, right angle, and overtaking crashes.

- Install traffic signal backplates, additional signal heads, flashing yellow left turn arrows and/or replace existing signals with far side mast arm signals.
- Assess commercial driveway widths and evaluate side street alignments to improve visibility.

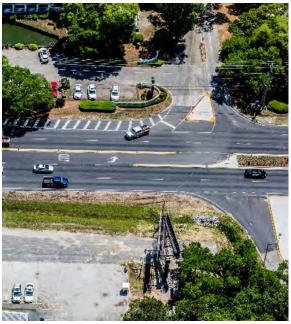
Example left turn restrictions

Outside of the intersection safety enhancements there are several corridor wide operations and safety improvements that should be evaluated.

- Traffic signal coordination to improve progression and minimize peak hour congestion
- Access management practices to address crashes associated with the high density of commercial driveways
- Limit left turns into or out of driveways and/ or assess the feasibility of a center median in lieu of the center left turn lane
